# CNRL's Persistent 2013-2014 Bitumen Releases near Cold Lake, Alberta: Facts, Unanswered Questions, and Implications

*Final Report (February 2014)*

Kevin Timoney (Treeline Ecological Research)

Peter Lee (Global Forest Watch Canada)

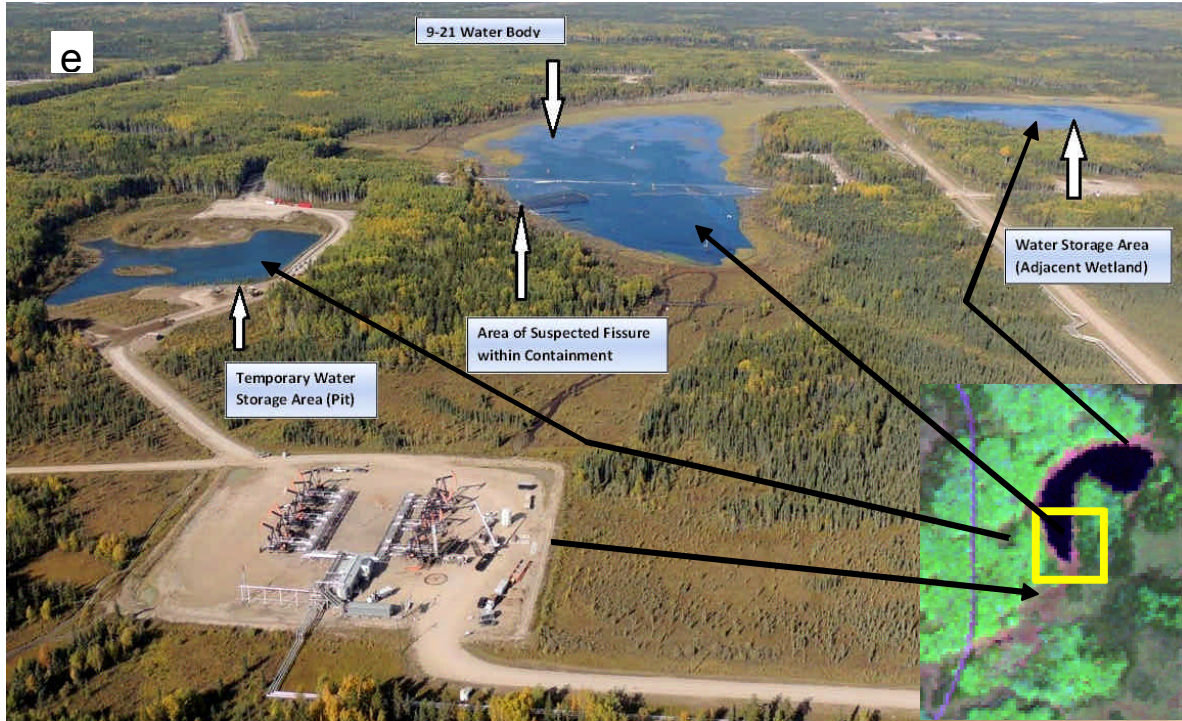
Figure 4, continued. (e) Oblique aerial view of spill site 4 (the 09-21 site). Image modified from CNRL (2013e); image date was not provided. The inset in the lower right is from a September 1987 false colour Landsat image (the yellow box indicates the legal location of the 09-21 spill site). Desiccation of the 09-21 lake post-1987 is evident as is the increase in landscape disturbance over the period. The placement of the well pad directly within the wetland drainage channel would have modified the local hydrology. The “storage area (pit)” was formerly a natural wetland. According to AER correspondence (4 October 2013), there is no well associated with the 09-21 bitumen release site.

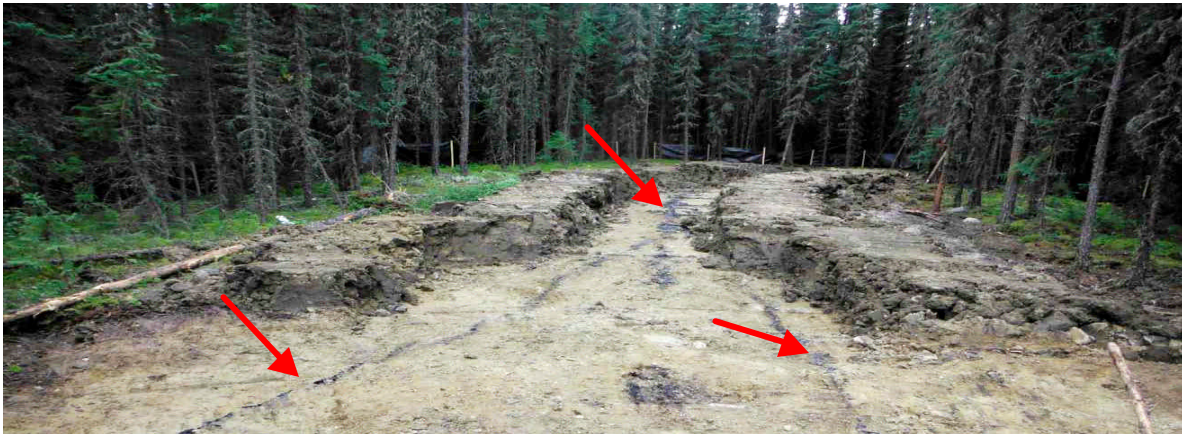
[Exposed Fissure at 2-22](#)

[Notes to accompany the image. This view of part of the excavation at the “02-22” release site reveals two bitumen-releasing fissures that converge near photo center (red arrows). The excavation trench cuts through an imperfectly-drained black spruce forest. The bitumen here is being released from a three-dimensional network of fissures, not from a single well bore. The three-dimensional spatial extent and volume of the bitumen releases below-ground have not been ascertained. Image modified after CNRL (2013 b).]

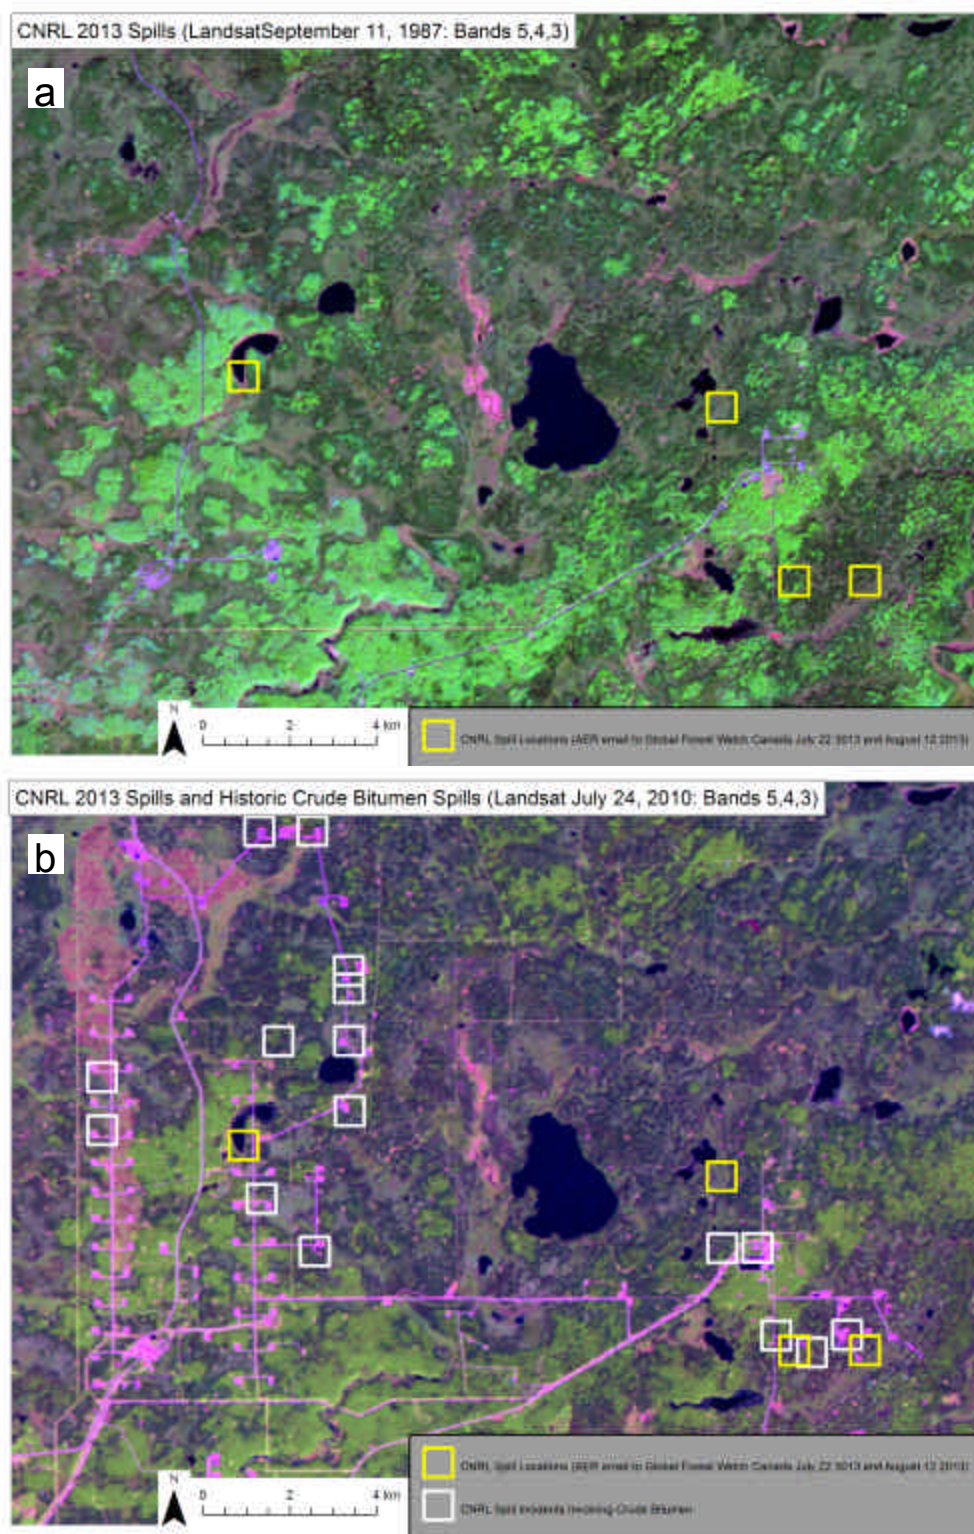
Figure 5. False-color infra-red satellite images of (a) the area of the four 2013 bitumen releases (yellow boxes) in September 1987 and (b) the area in July 2010. Other bitumen releases attributed to CNRL in the area near the 2013 releases are plotted (white boxes) based on the ERCB spills database. The increase in landscape disturbance over the 26-year period is significant.

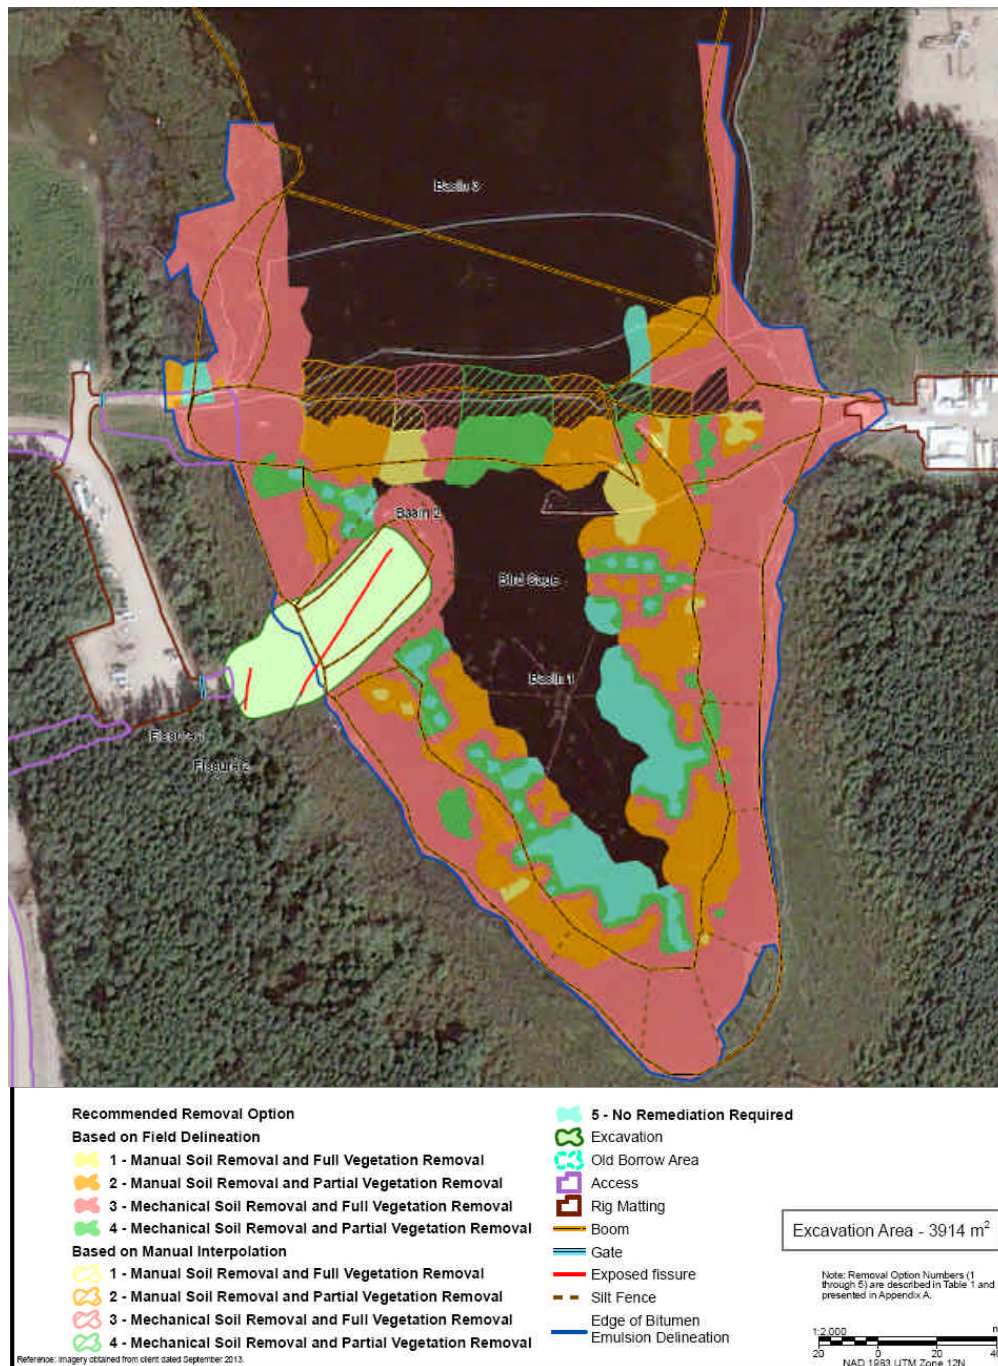
Figure 7. The south end of the 09-21 spill site. The blue line denotes the edge of the bitumen emulsion as delineated by CNRL. The yellow, orange, and green polygons denote the recommended removal options for contaminated soil and vegetation. The red lines on the west (left) of the 09-21 lake denote bitumen release fissures. Image modified from Figure 5 in CNRL (2013i).

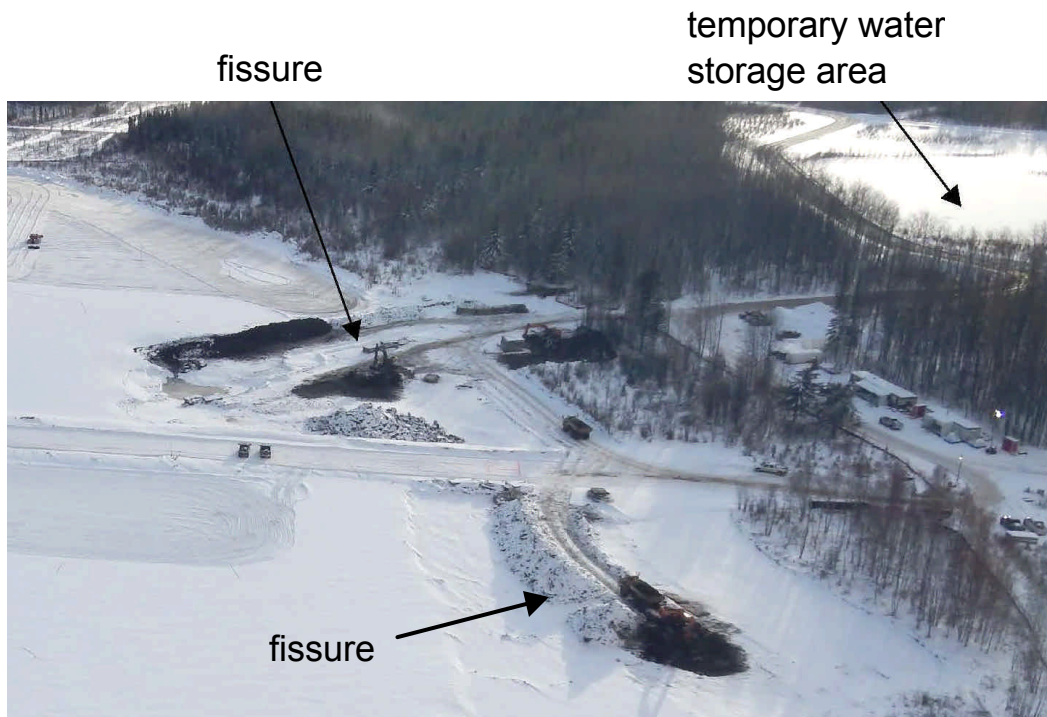
Figure 8. The two “suspected fissure” sites on the west side of 09-21 lake on 15 December 2013. Note the accumulations of black materials in the vicinity of the fissures. Image downloaded and modified from CNRL (<http://www.cnrl.com>; aerial-photograph-9-21-site-december-15-2013.jpg).

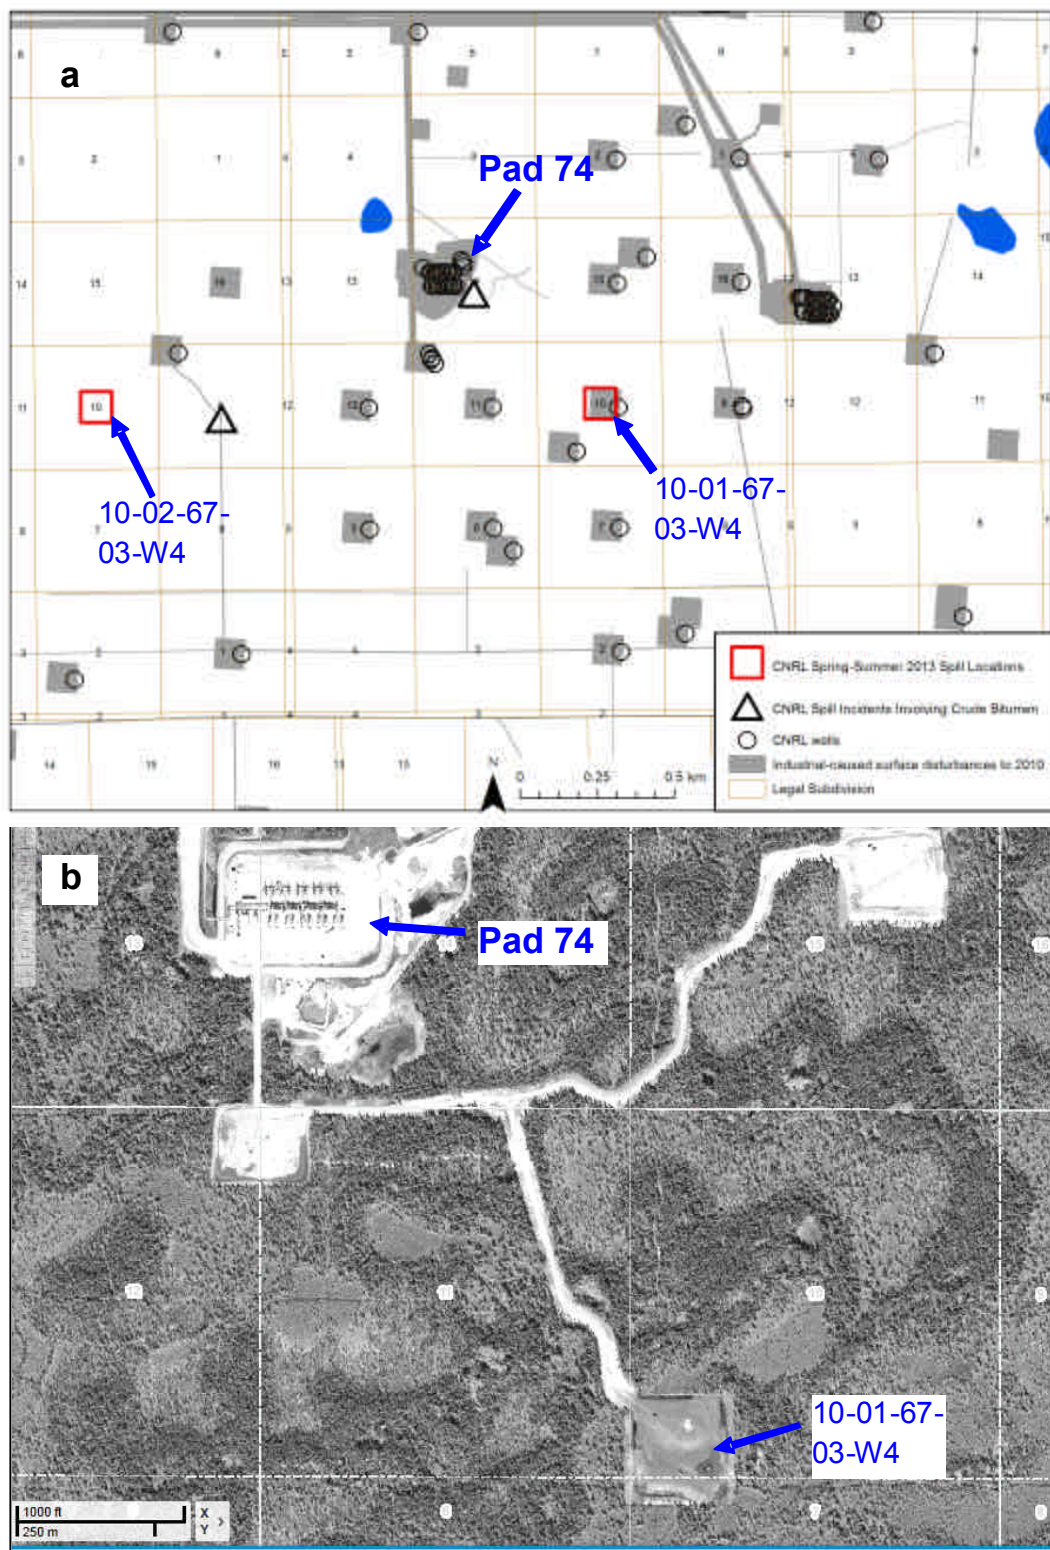
Figure 10. (a) Locations of two winter-summer 2013 CNRL bitumen releases (10-01-67-03-W4, 10-02-67-03-W4) in relation to CNRL Pad 74. The numbers in the center of each square are the LSDs. (b) Aerial view of the vicinity of the Pad 74 and 10-01-67-03-W4 bitumen release sites from an undated Government of Alberta image. Note the large scale of the images.
