**Canadian Natural**

## **PRIMROSE FLOW TO SURFACE CAUSATION REPORT**

**ALBERTA ENERGY REGULATOR AND ALBERTA ENVIRONMENT AND SUSTAINABLE RESOURCE  
DEVELOPMENT**

June 27, 2014

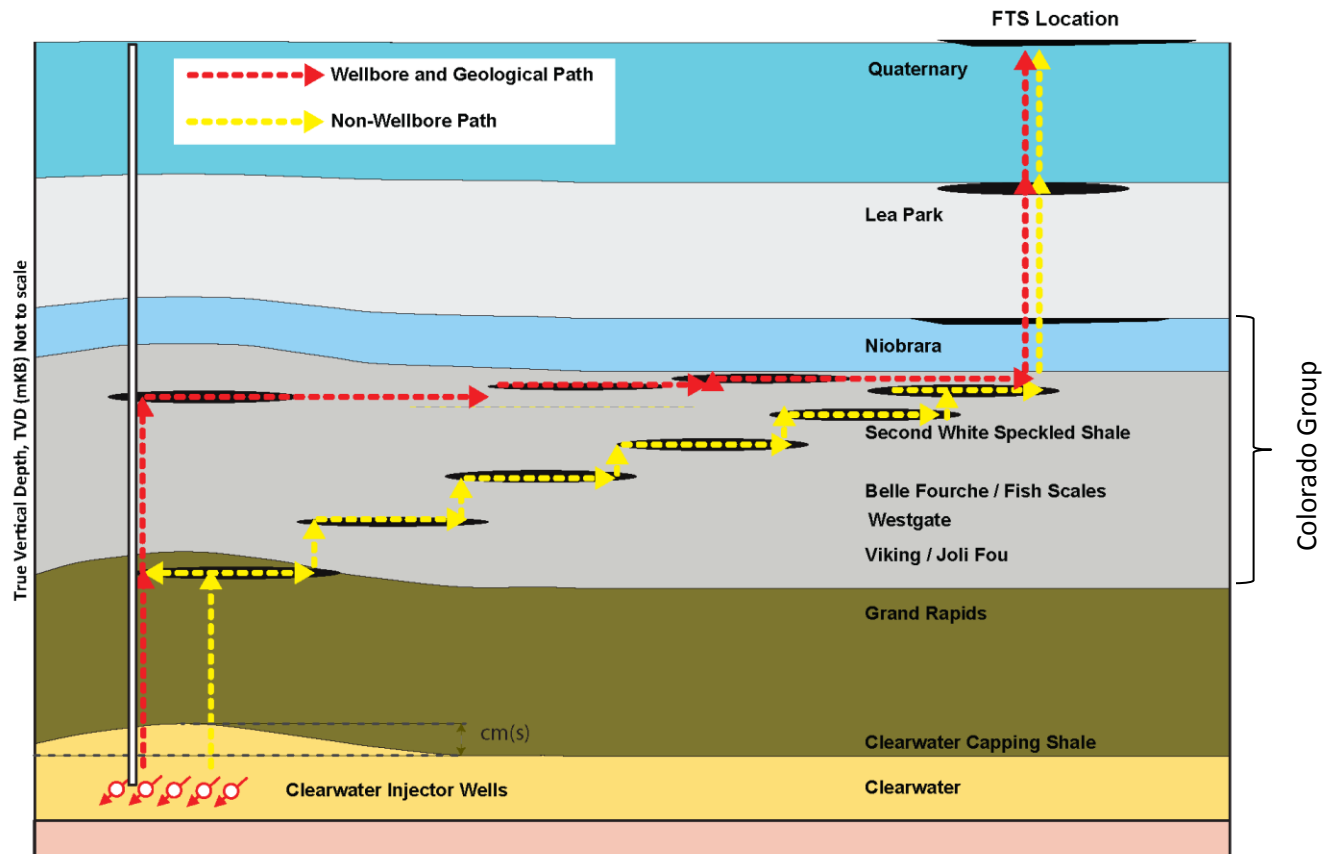
**Figure 1-1 Conceptual Schematic of Possible Flow Paths**

In summary, the cause of the Primrose FTS events indicates that four enabling conditions have been observed at each FTS location. To ensure a future FTS event cannot occur again, all four conditions must be addressed.

Although not within the scope of this report, the identified causes indicate that changes to steaming strategies and enhanced monitoring, as well as remediation of defective wellbores can prevent the conditions for FTS events.

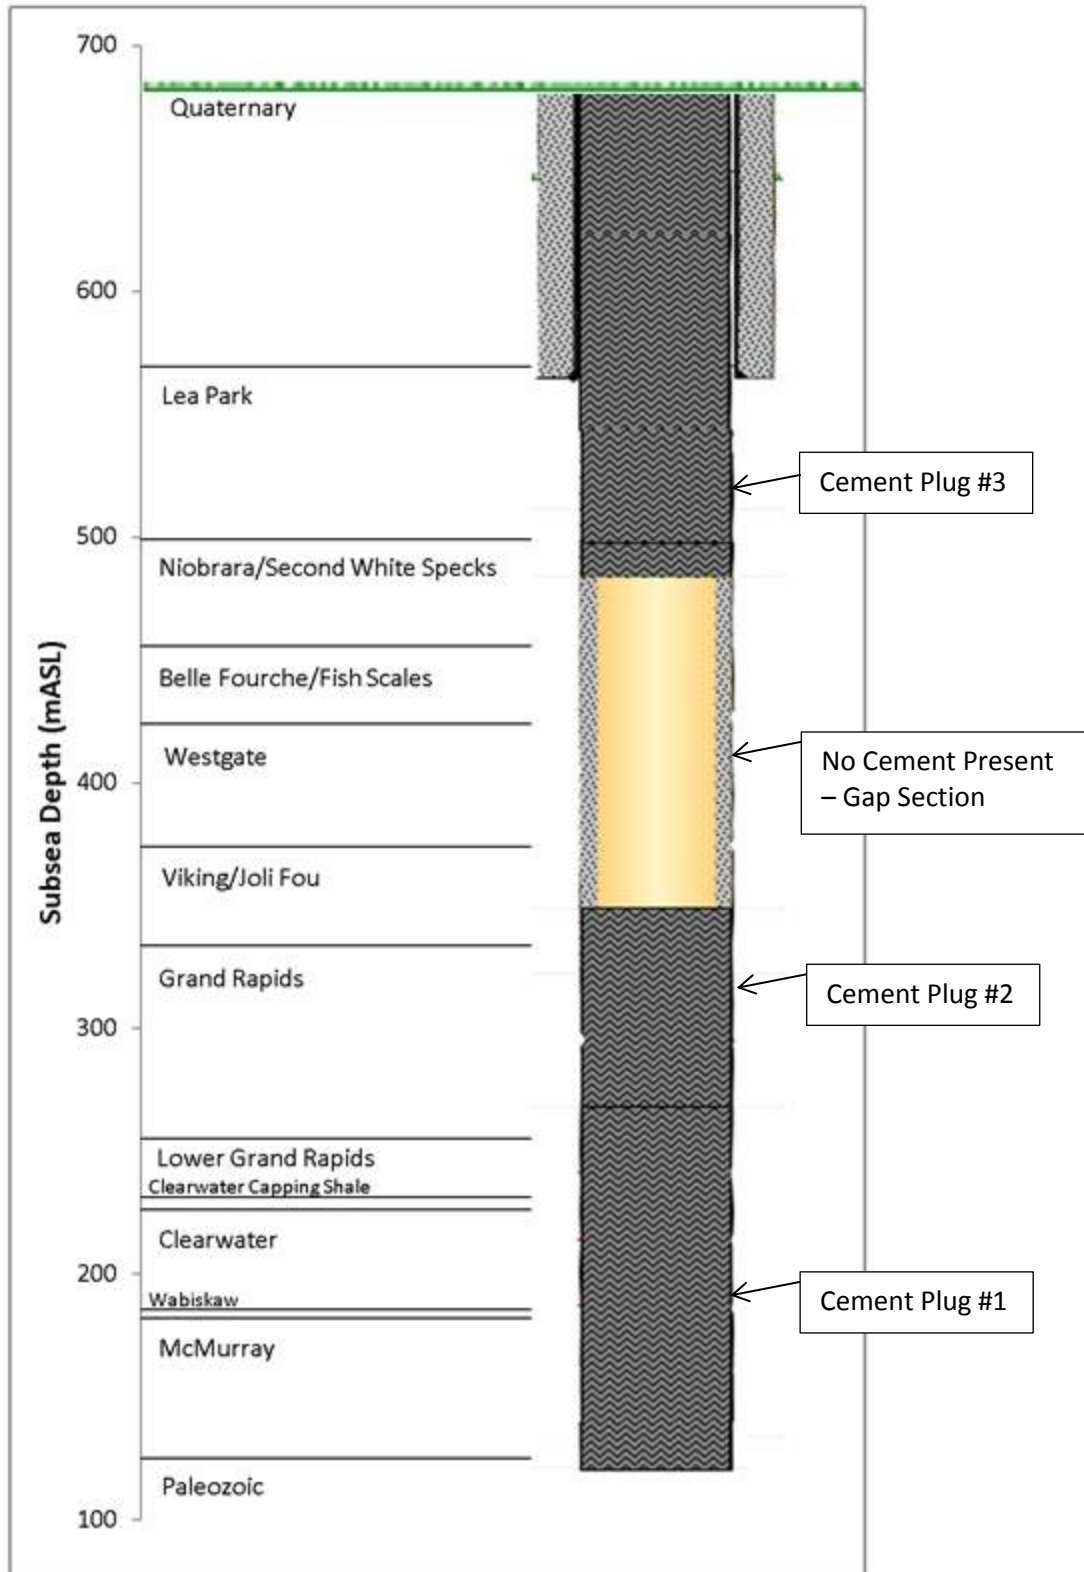
Figure 7-1 Conceptual diagram of the theoretical cement placement for DOME AEC 100/07-22-067-03W4

Review of the DOME AEC 100/7-22-67-3W4 wellbore (drilled in 1984) at the 2-22 FTS location revealed a certain vintage of OSE wells which do not have cement over much of the Colorado Group interval (Figure 7-1). The DOME AEC 100/7-22-67-3W4 wellbore has been shown to be an integral part of the FTS events at the 2-22 location. A review of the region identified a number of other wells with a similar abandonment technique. In addition to the DOME AEC 100/7-22-67-3W4 the re-abandonment of the DOME AEC 100/7-22-67-4W4 well has shown that cement plug #2 was not present. Due to the deficiencies found at the DOME AEC 100/7-22-67-3W4 and DOME AEC 100/7-22-67-4W4 wellbores and the known gap over much of the Colorado Group interval, Canadian Natural has chosen to re-abandon this vintage of wells such that the entire wellbore is abandoned with pipe to ensure the quality of the cement job and allow for future re-entry if necessary. As part of the FTS study, OSE wells that have questionable abandonment practices have been evaluated using plug tracking technology. The only known wellbore abandoned with this practice and involved with FTS events is the DOME AEC 100/7-22-67-3W4.

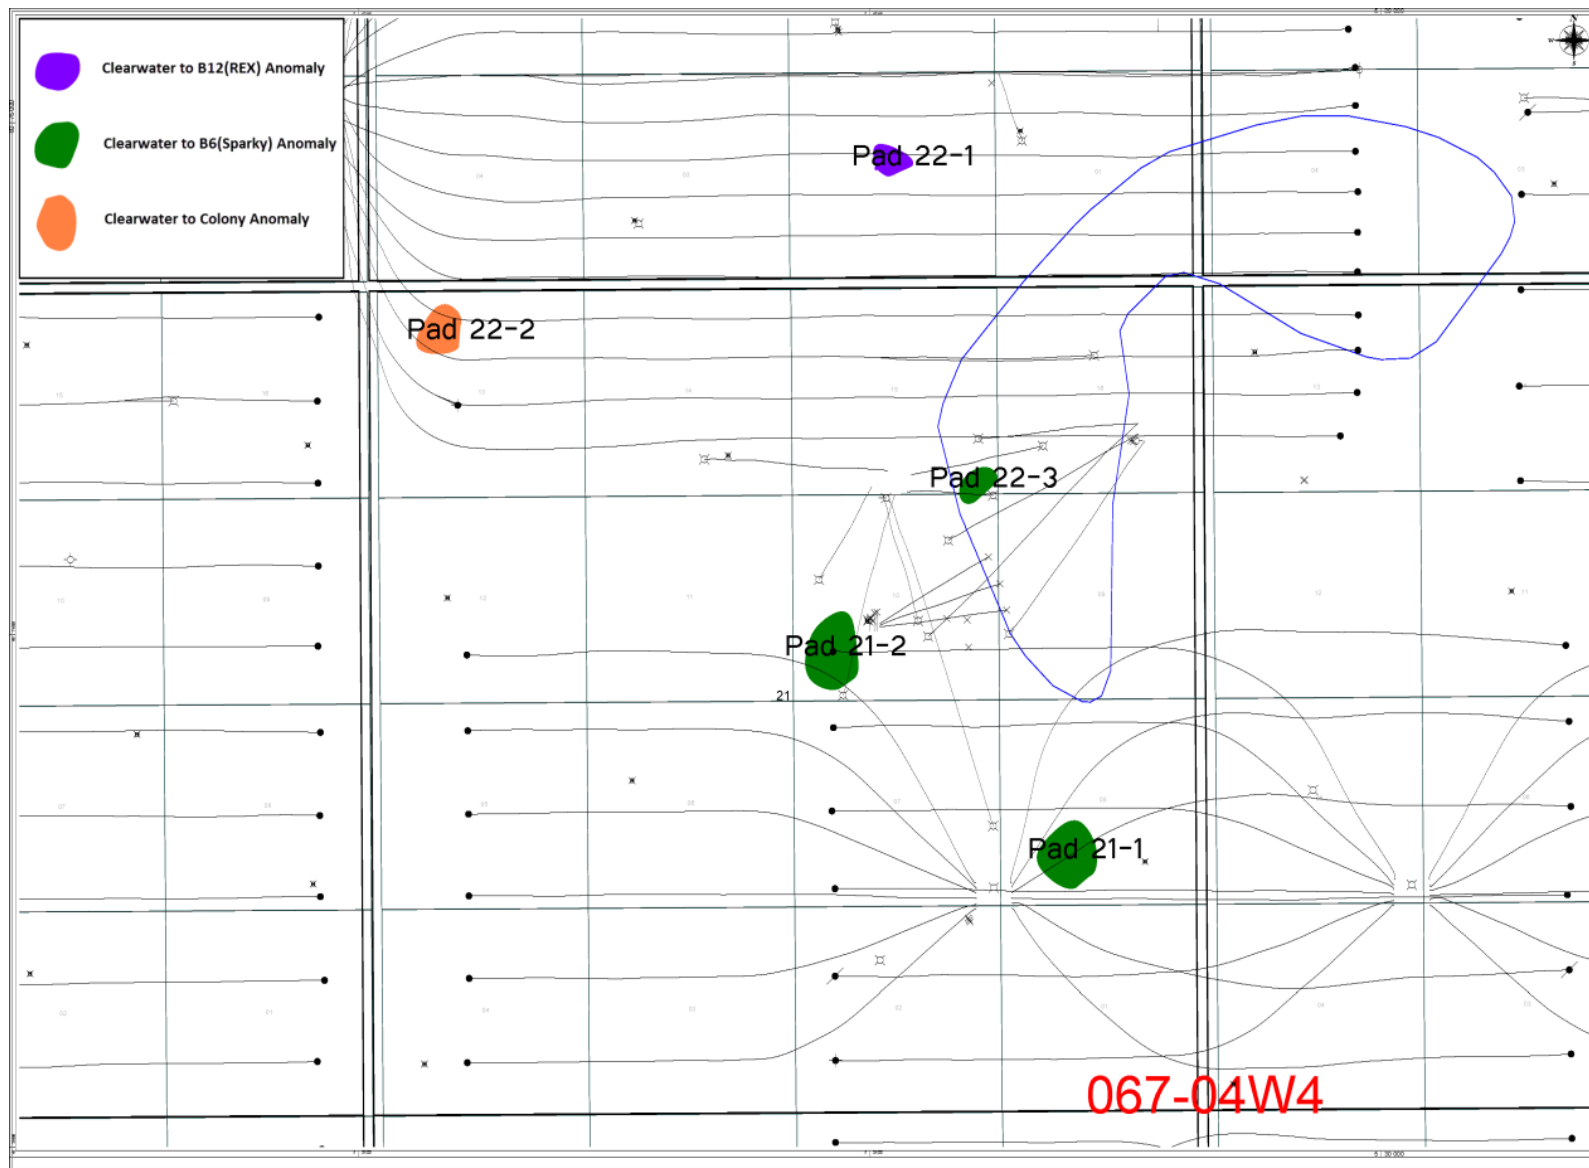
Figure 9-3 Simplified Grand Rapids Formation Post Steam Seismic Anomaly Location Map for 9-21 FTS

These seismic anomalies are characterized by highly localized often circular amplitude changes and push down effects observed in post steam seismic volumes. Modelling and drilling data suggests the seismic features are observed because of the presence of liberated solution gas from the bitumen, but pressure and temperature effects may also play a role. Mapping of these anomalies shows that most do not extend to the top of the Grand Rapids Formation.

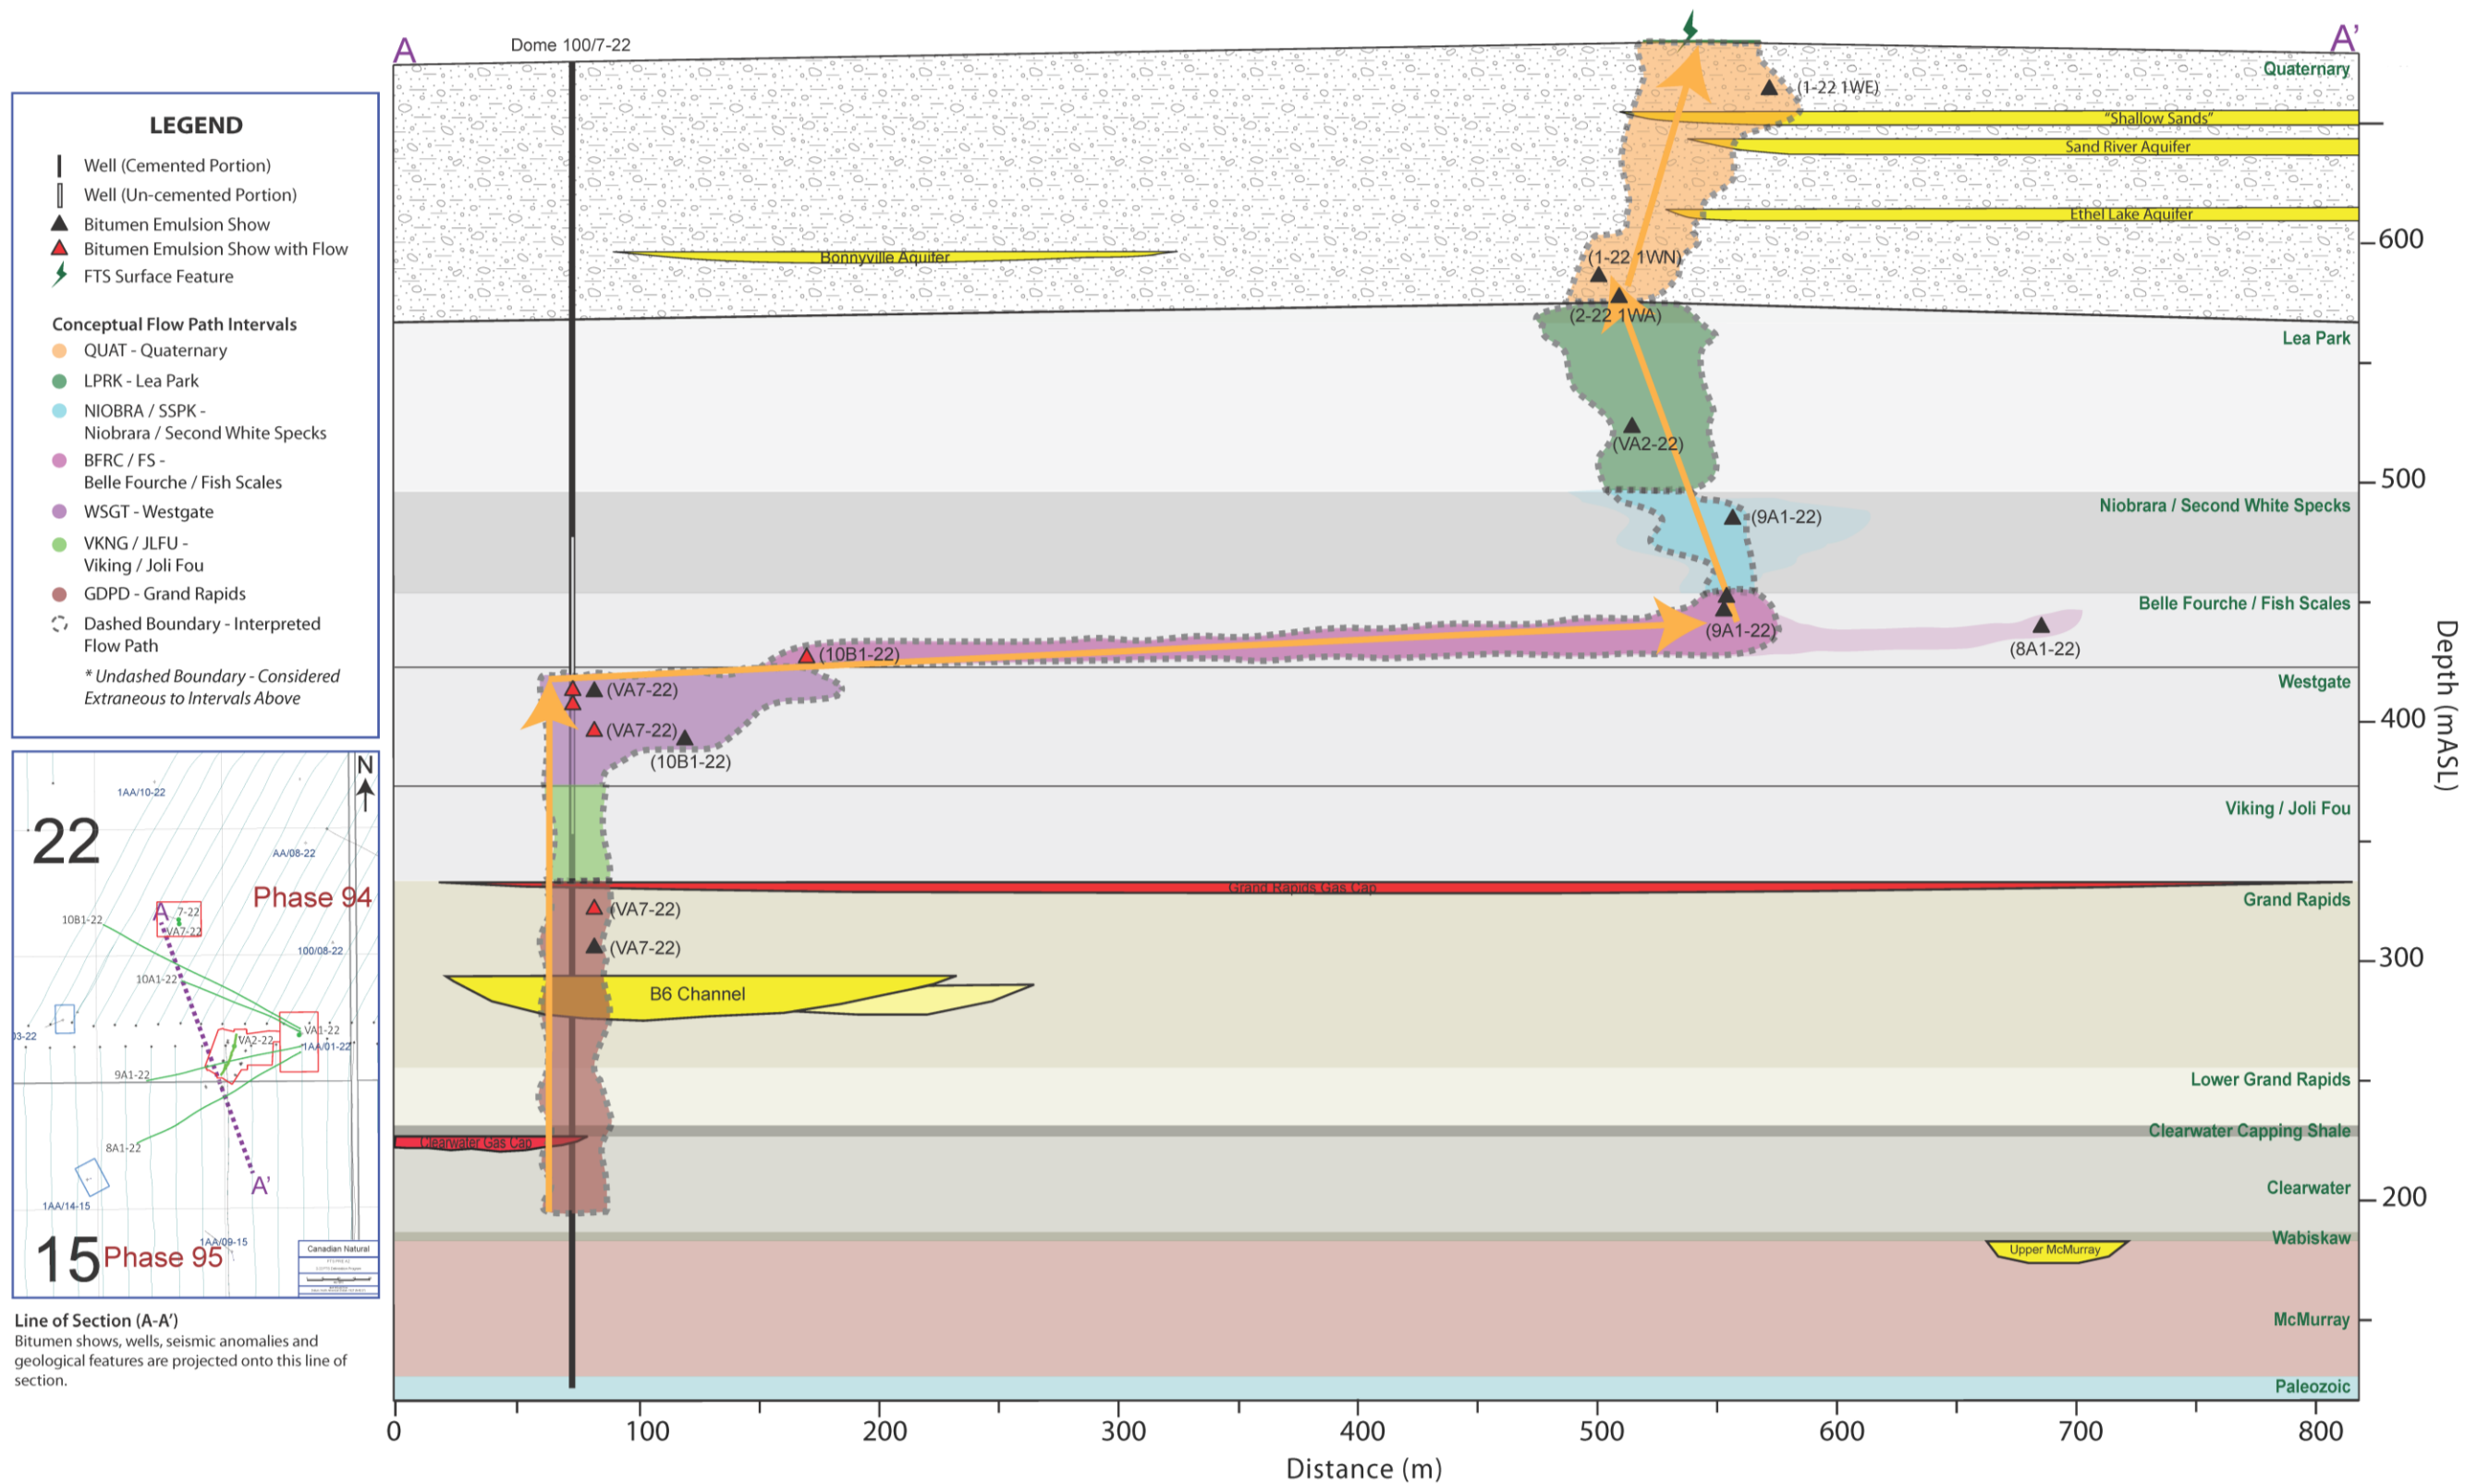
Figure 10-1 2-22 FTS – Features, Data and Conceptual Flow Path Projected on N-S Plane

The failed DOME AEC 100/7-22-67-3W4 OSE wellbore acted as a flow path for fluid migration from the Clearwater reservoir to the top of the Westgate Formation. The mechanism for fluid flow through the remainder of the Colorado Group to surface has been determined using drilling, geological, geomechanical, and geochemical data collected throughout the study of FTS events.

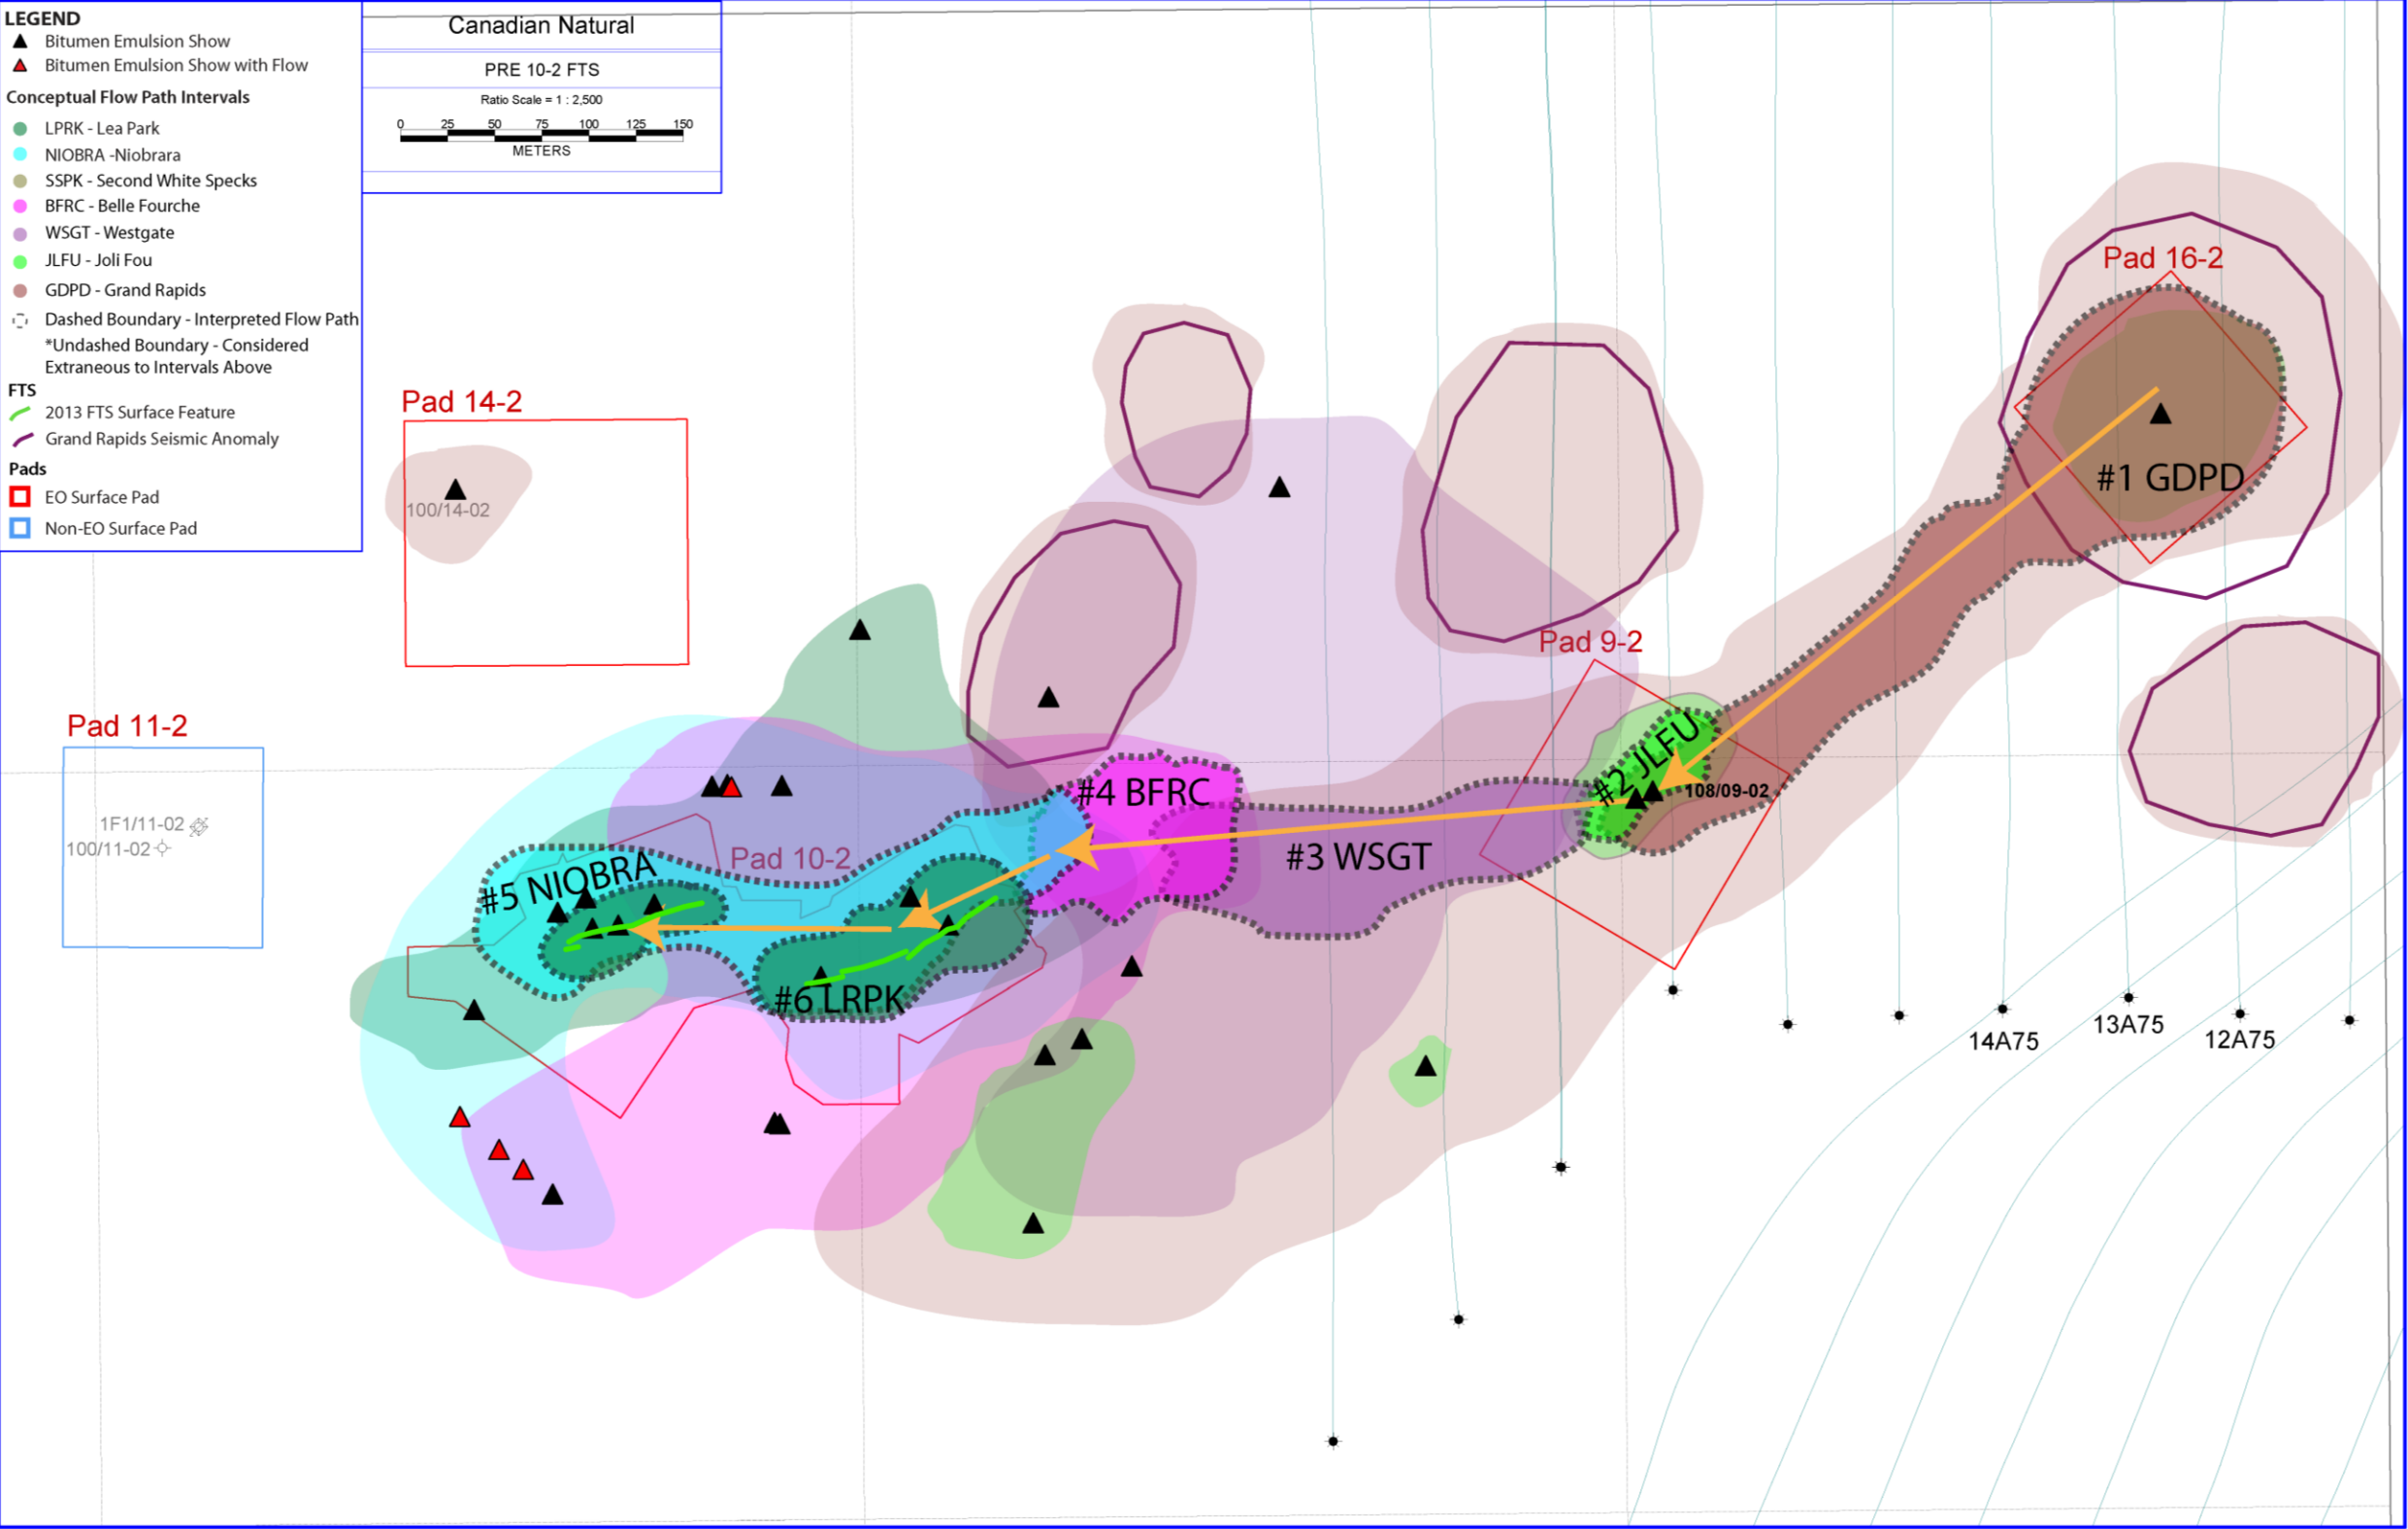
Figure 10-4 10-2 FTS – Conceptual Plan View of Bitumen Emulsion Shows

The poor cement bond quality in the 108/9-2-67-3W4 OSE wellbore facilitated fluid migration from the Grand Rapids Formation to the Viking Formation. The mechanism for fluid flow through the remainder of the Colorado Group to surface has been determined using drilling, geological, geomechanical, and geochemical data collected throughout the study of FTS events.

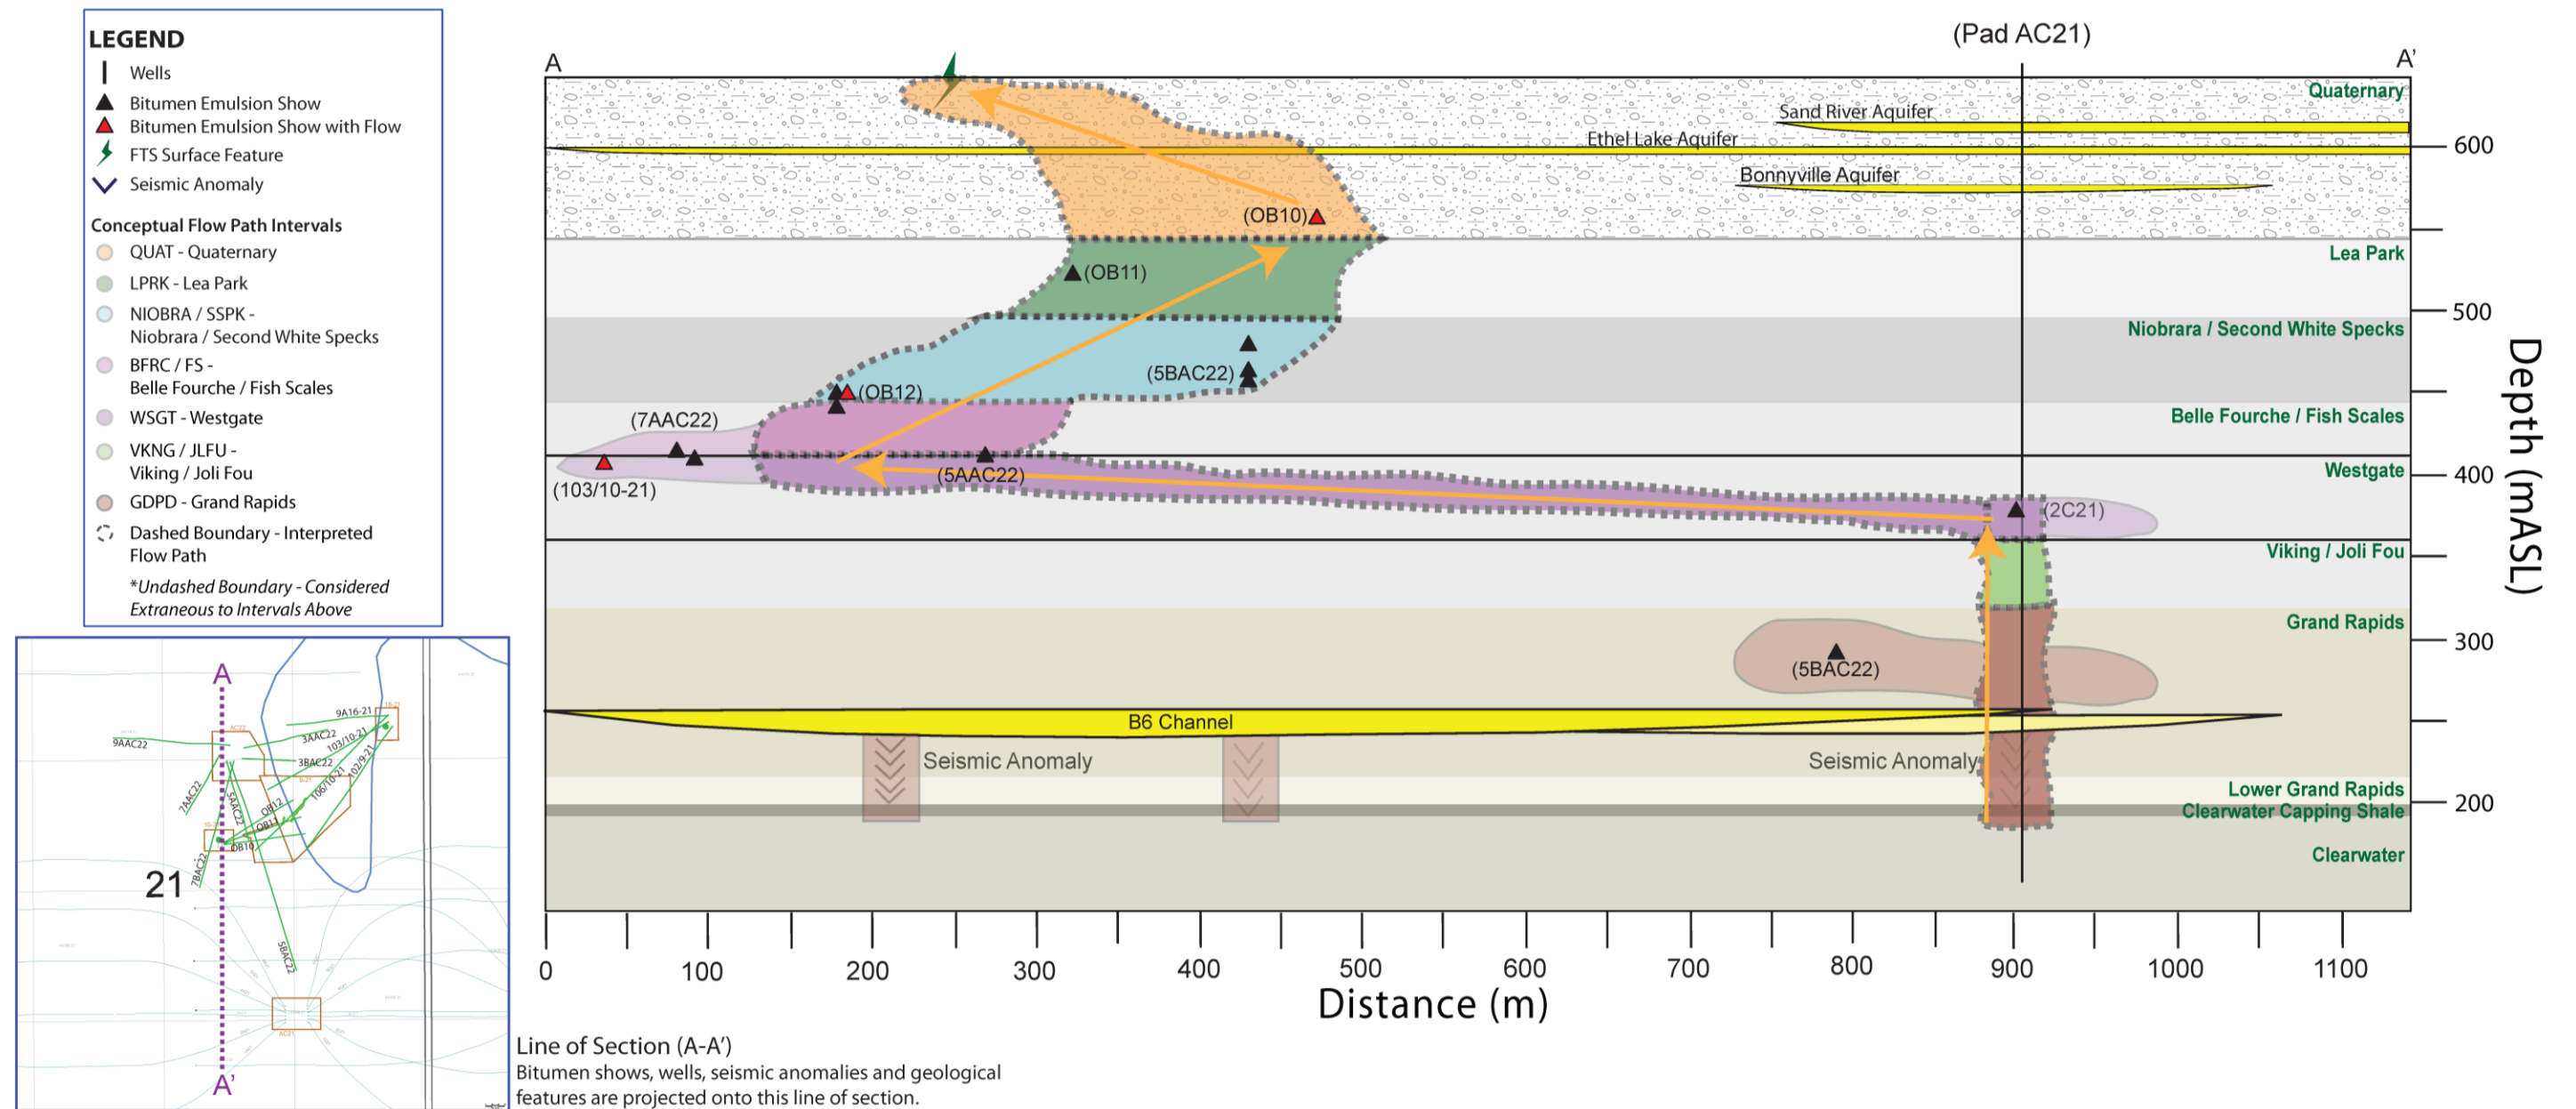
Figure 10-5 9-21 FTS – Features, Data and Conceptual Flow Path Projected on N-S Plane

It is suspected that inadequate placement of primary cement of a well within the vicinity of Pad AC21 facilitated fluid migration from the Clearwater reservoir to the Westgate Formation several years ago. Steam injection and operation of Pad 22 during the most recent cycle in 2013 imposed uplift induced stresses on the Colorado Group and facilitated further fluid migration from the Westgate Formation. The mechanism for fluid flow through the remainder of the Colorado Group to surface has been determined using drilling, geological, geomechanical, and geochemical data collected throughout the study of FTS events.

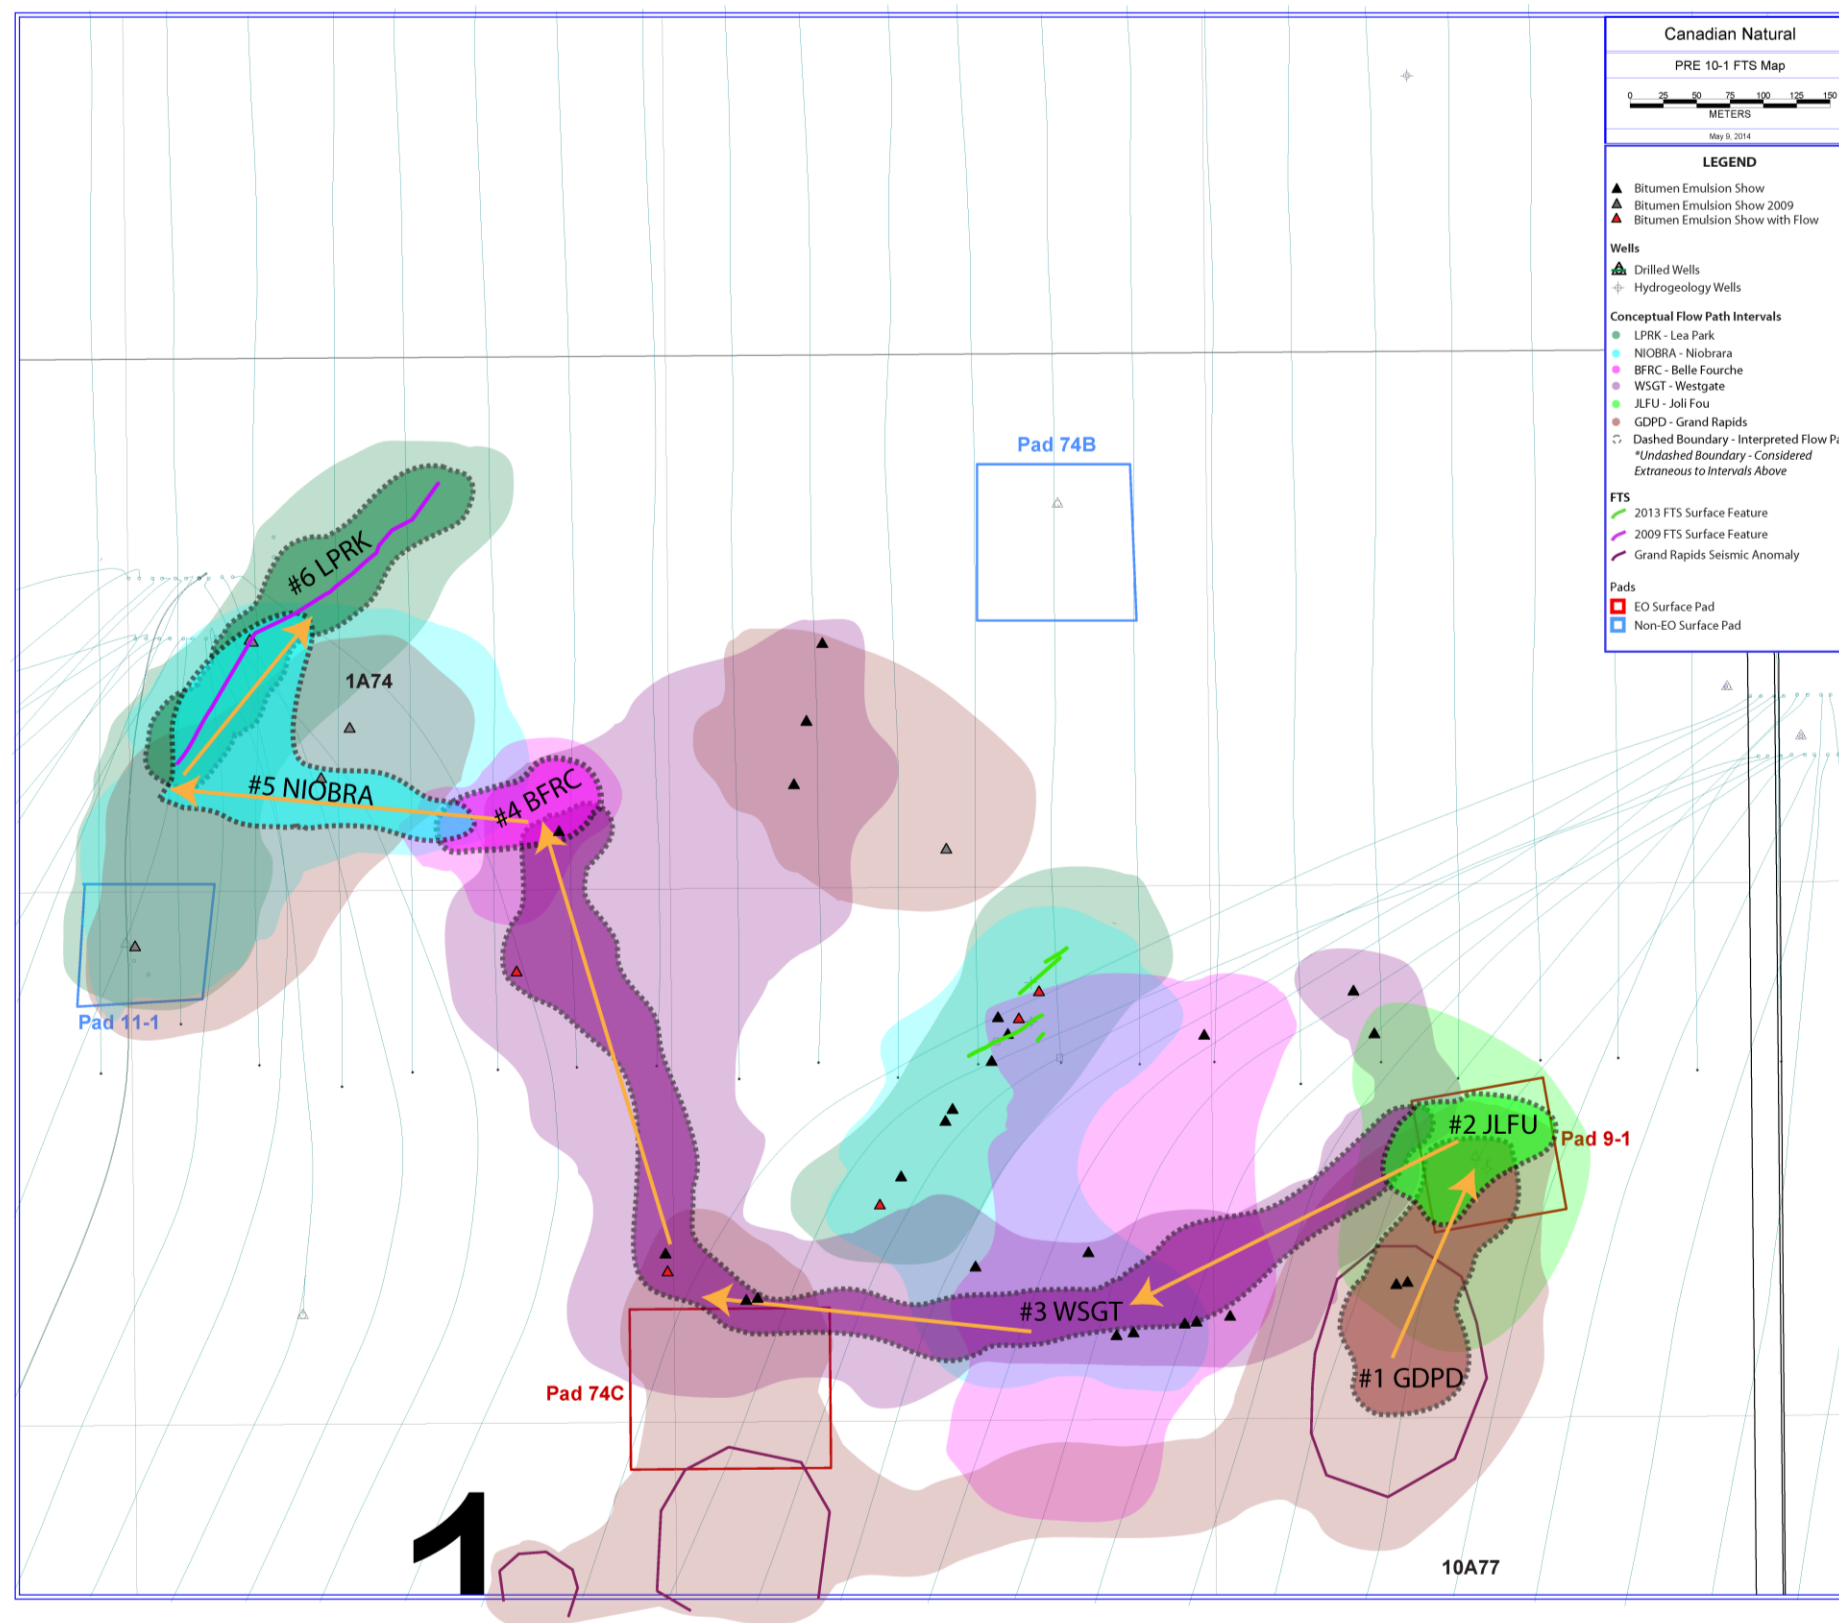
Figure 10-8 Pad 74 FTS – Conceptual Plan View of Bitumen Emulsion Shows

The 1AA/09-01-067-03W4 OSE wellbore most likely acted as a pathway for fluid migration to the top of the Joli Fou Formation. The mechanism for fluid flow through the remainder of the Colorado Group to surface has been determined using drilling, geological, geomechanical, and geochemical data collected throughout the study of FTS events.

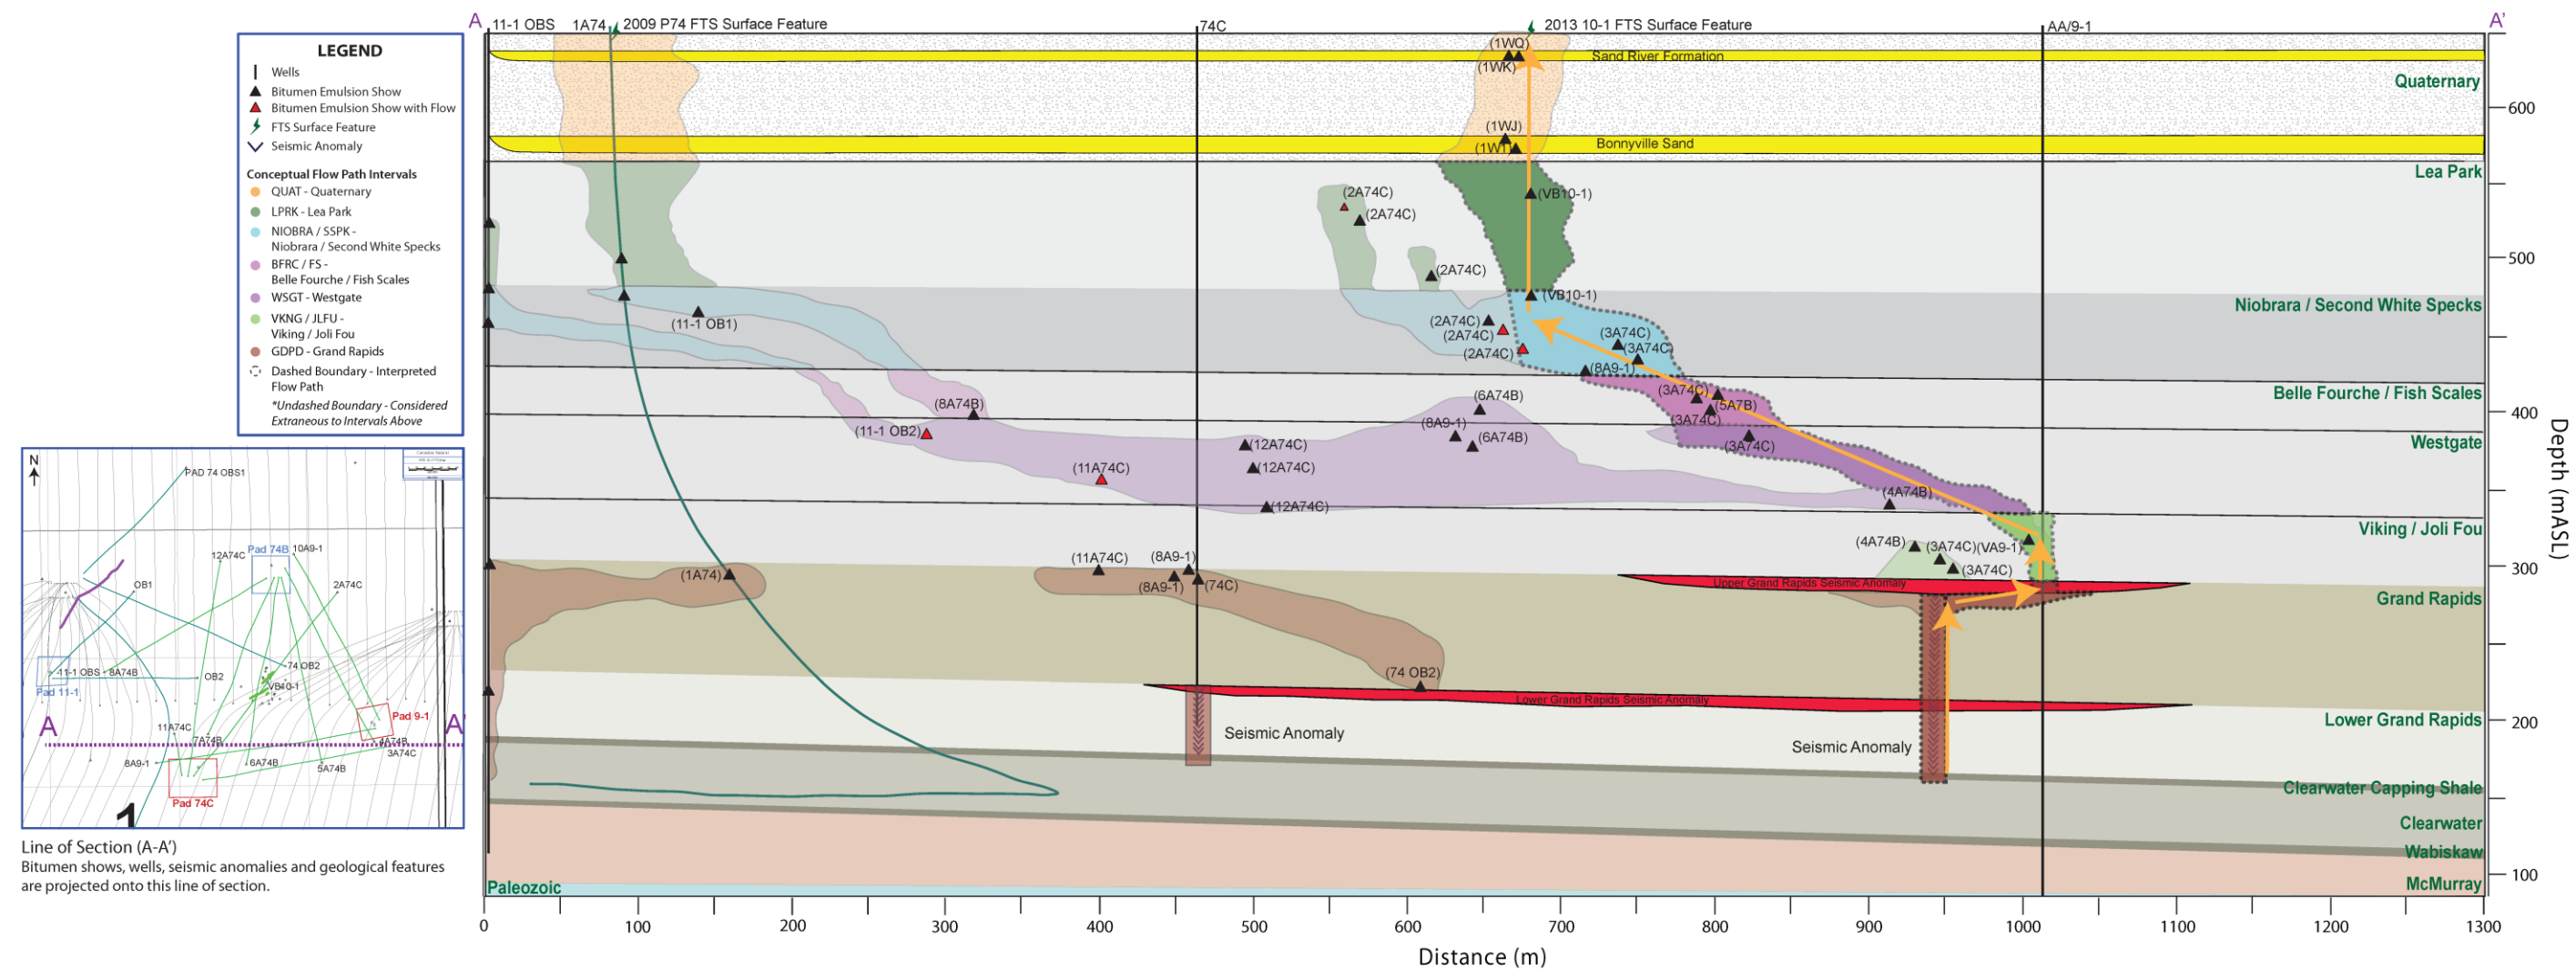
Figure 10-9 10-1 FTS – Features, Data and Conceptual Flow Path Projected on W-E Plane

The 1AA/09-01-067-03W4 OSE wellbore most likely acted as a pathway for fluid migration to the top of the Joli Fou Formation. The mechanism for fluid flow through the remainder of the Colorado Group to surface has been determined using drilling, geological, geomechanical, and geochemical data collected throughout the study of FTS events.
