# CNRL's Persistent 2013-2014 Bitumen Releases near Cold Lake, Alberta: Facts, Unanswered Questions, and Implications

*Final Report (February 2014)*

Kevin Timoney (Treeline Ecological Research)

Peter Lee (Global Forest Watch Canada)

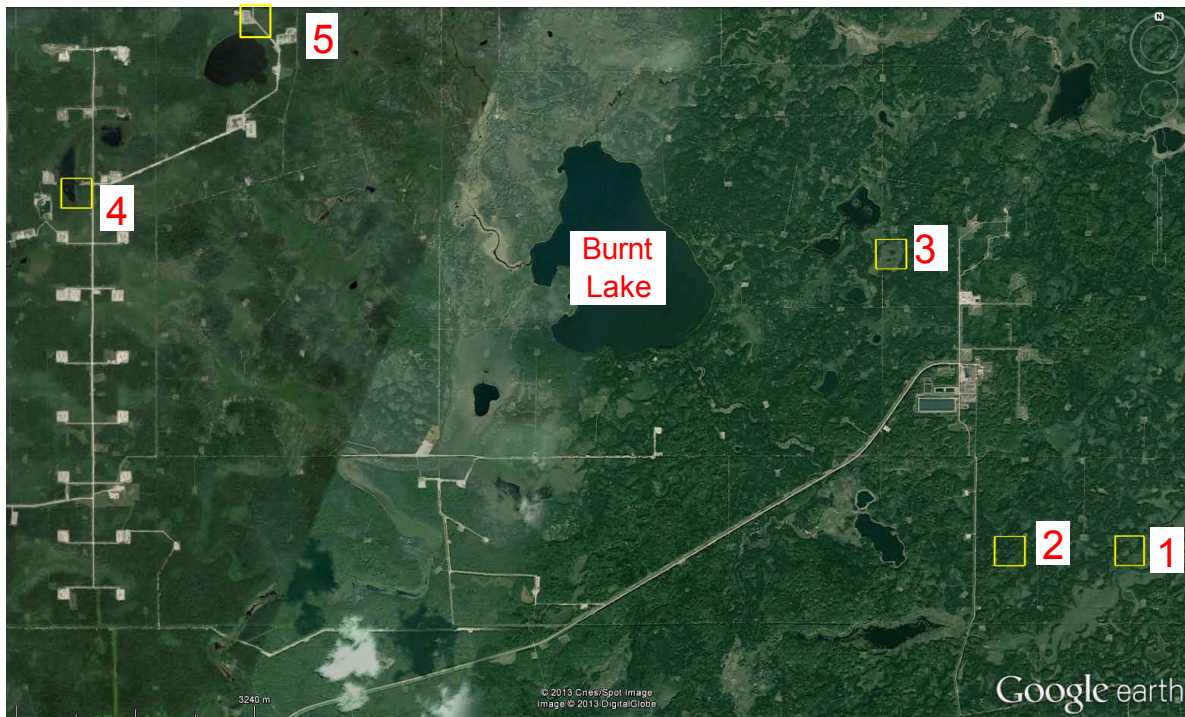
Figure 3. Locations of the 2013-2014 CNRL bitumen release sites within the context of the local landscape, which is predominantly a bog and fen peatland complex, as plotted on a Google Earth mosaic constructed from images taken on 19 June 2005 and 7 July 2005. 2013 Locations: (1) LSD 10, Sect. 01, Twp 67, Rge 03, W4; (2) LSD 10, Sect. 02, Twp 67, Rge 03, W4; (3) LSD 02, Sect. 22, Twp 67, Rge 03, W4; and (4) LSD 09, Section 21, Township 67, Range 04, W4. (5) LSD 03, Sect. 35, Twp 67, Rge 4, W4; this is the January 2014 CRNL bitumen release, AER incident number 20140048 (location provided by M. Darwent, AER, 28 January 2014). Pad 74, the site of the 2009 bitumen release, did not exist in 2005; it is located in LSD 14, Sect. 01, Twp 67, Rge 03, W4, ~ 700 m northwest of site (1); for the location of Pad 74, see Figure 4.

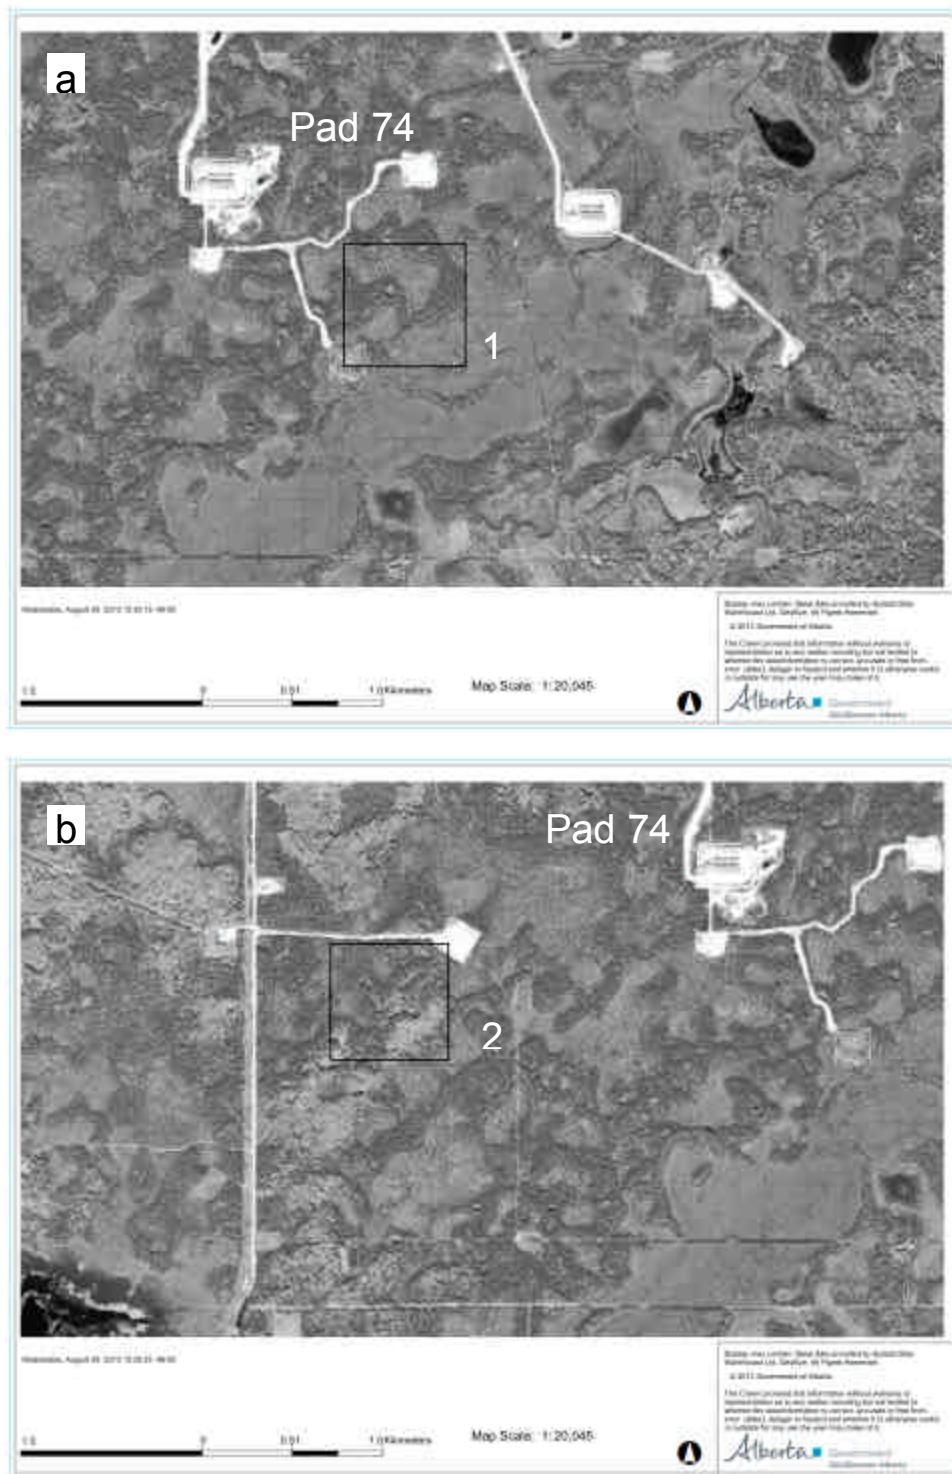
Figure 4. (a) CNRL spill site 1 (10-01) and (b) spill site 2 (10-02), delimited by black squares. Positions are based on legal locations provided by AER . Note the proximity of CNRL Pad 74.

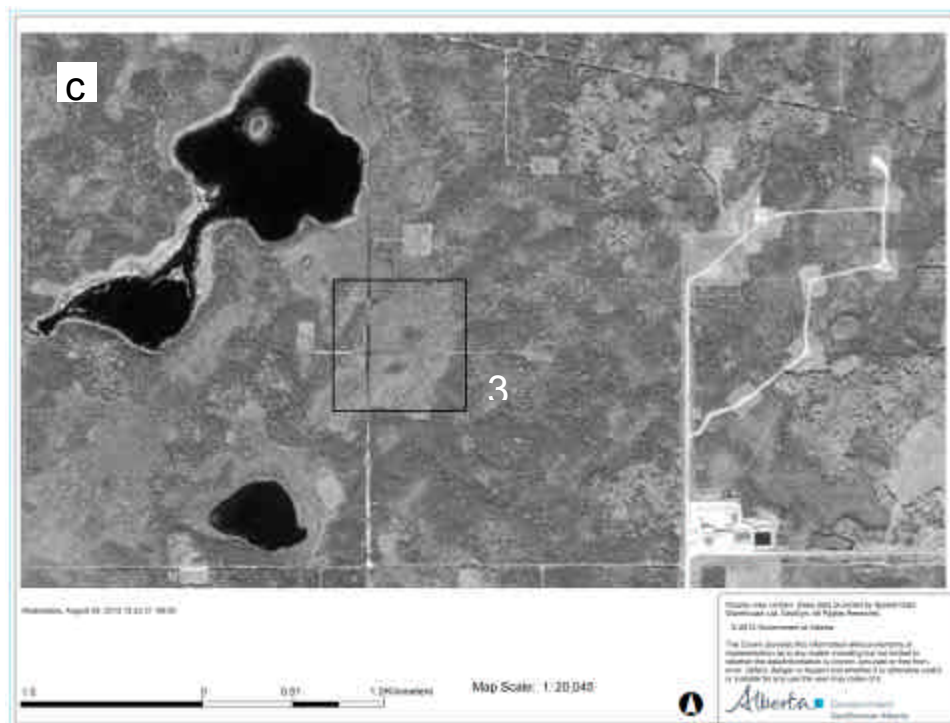
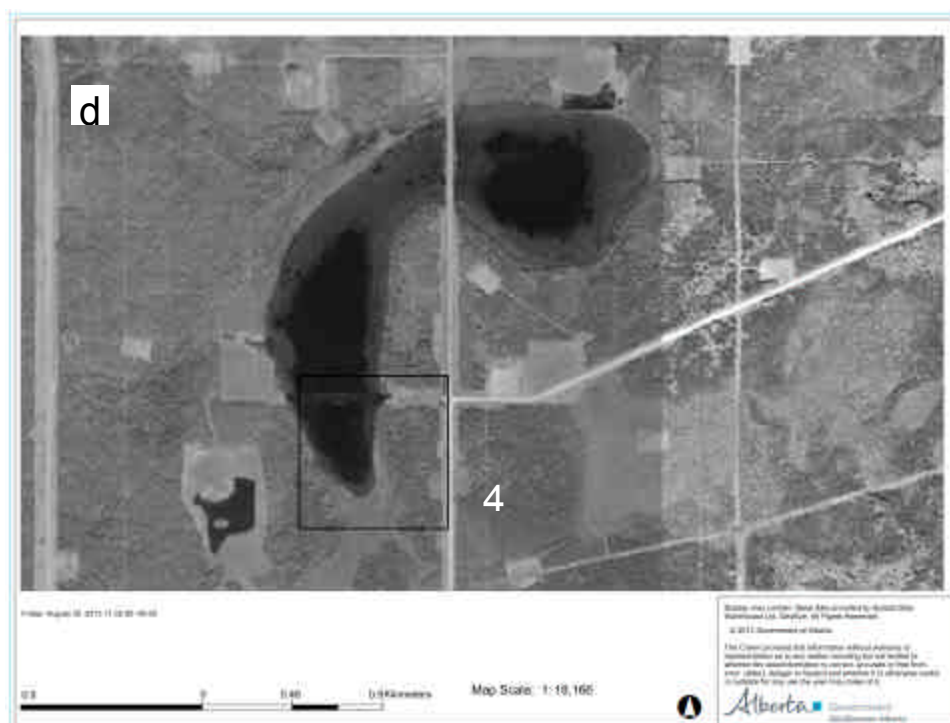
[There are four affected areas, not one, and at each site, water would have been affected because all four sites are located within wetland complexes (Figures 3 and 4). Secondly, the affected waterbody at release site 09-21-67-04W4 is a 50.3 ha lake, not a slough (Figure 4, panels d, e). The 31 July 2013 CNRL press release states that this lake is a “shallow slough that does not flow in or interact with other water bodies”. Detailed aerial imagery released in December 2013 (CNRL 2013i) indicates that water flow in the spill site 4 peatland complex is towards the south then west into the Wolf River (see Figure 3, upper left corner).]

Figure 4, continued. (c) CNRL spill site 3 (02-22) and (d) spill site 4 (09-21), delimited by black squares. Positions are based on legal locations provided by AER.

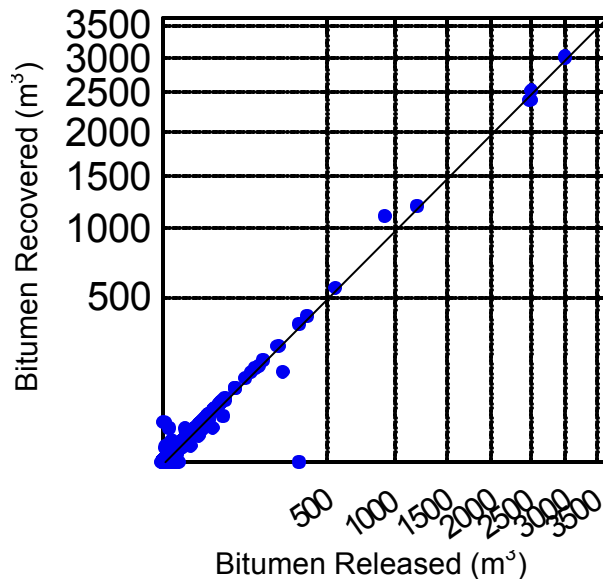
Figure 6. Relationship between crude bitumen released and recovered based on ERCB release data. The diagonal line depicts a perfect 1:1 relationship between volume released and volume recovered. Points above the line indicate that more bitumen was recovered than was released. Both the x and y-axes are power-transformed (power = 0.5) to better depict the lower values. There are 856 data points; hundreds of data points overlap.

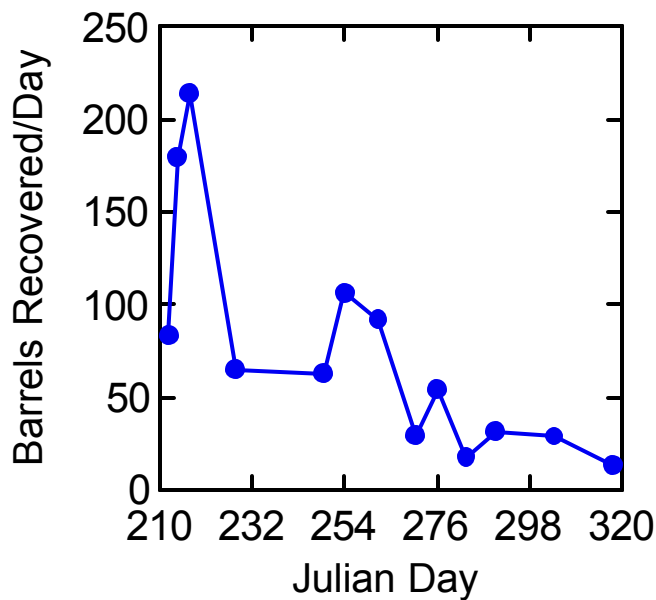
As of the 19 September 2013 update, the rate of bitumen recovery was 91.6 barrels/day over the period 11 to 19 September 2013. Although CNRL stated that the volume of bitumen released/day at the four sites had fallen to “less than 20 barrels/day” as of 31 July, the volume of bitumen recovered/day showed no clear downward trend until mid-September (Figure 9).

Over the period late-September to mid-November, the daily volume of bitumen recovered varied as follows: 29.1 (on 28 September), 54.0 (on 3 October), 17.7 (on 10 October), 31.4 (on 17 October), 28.7 (on 31 October), and 13.3 barrels/day (on 14 November). It is difficult to predict when the bitumen releases may cease (Figure 9).]

Figure 9. Barrels recovered per day at the four CNRL release sites over the period late-July through mid-November 2013. Due to discrepancies in the total barrels recovered as reported in January 2014, no data points after 14 November 2013 are plotted. Data are derived from Table 2.

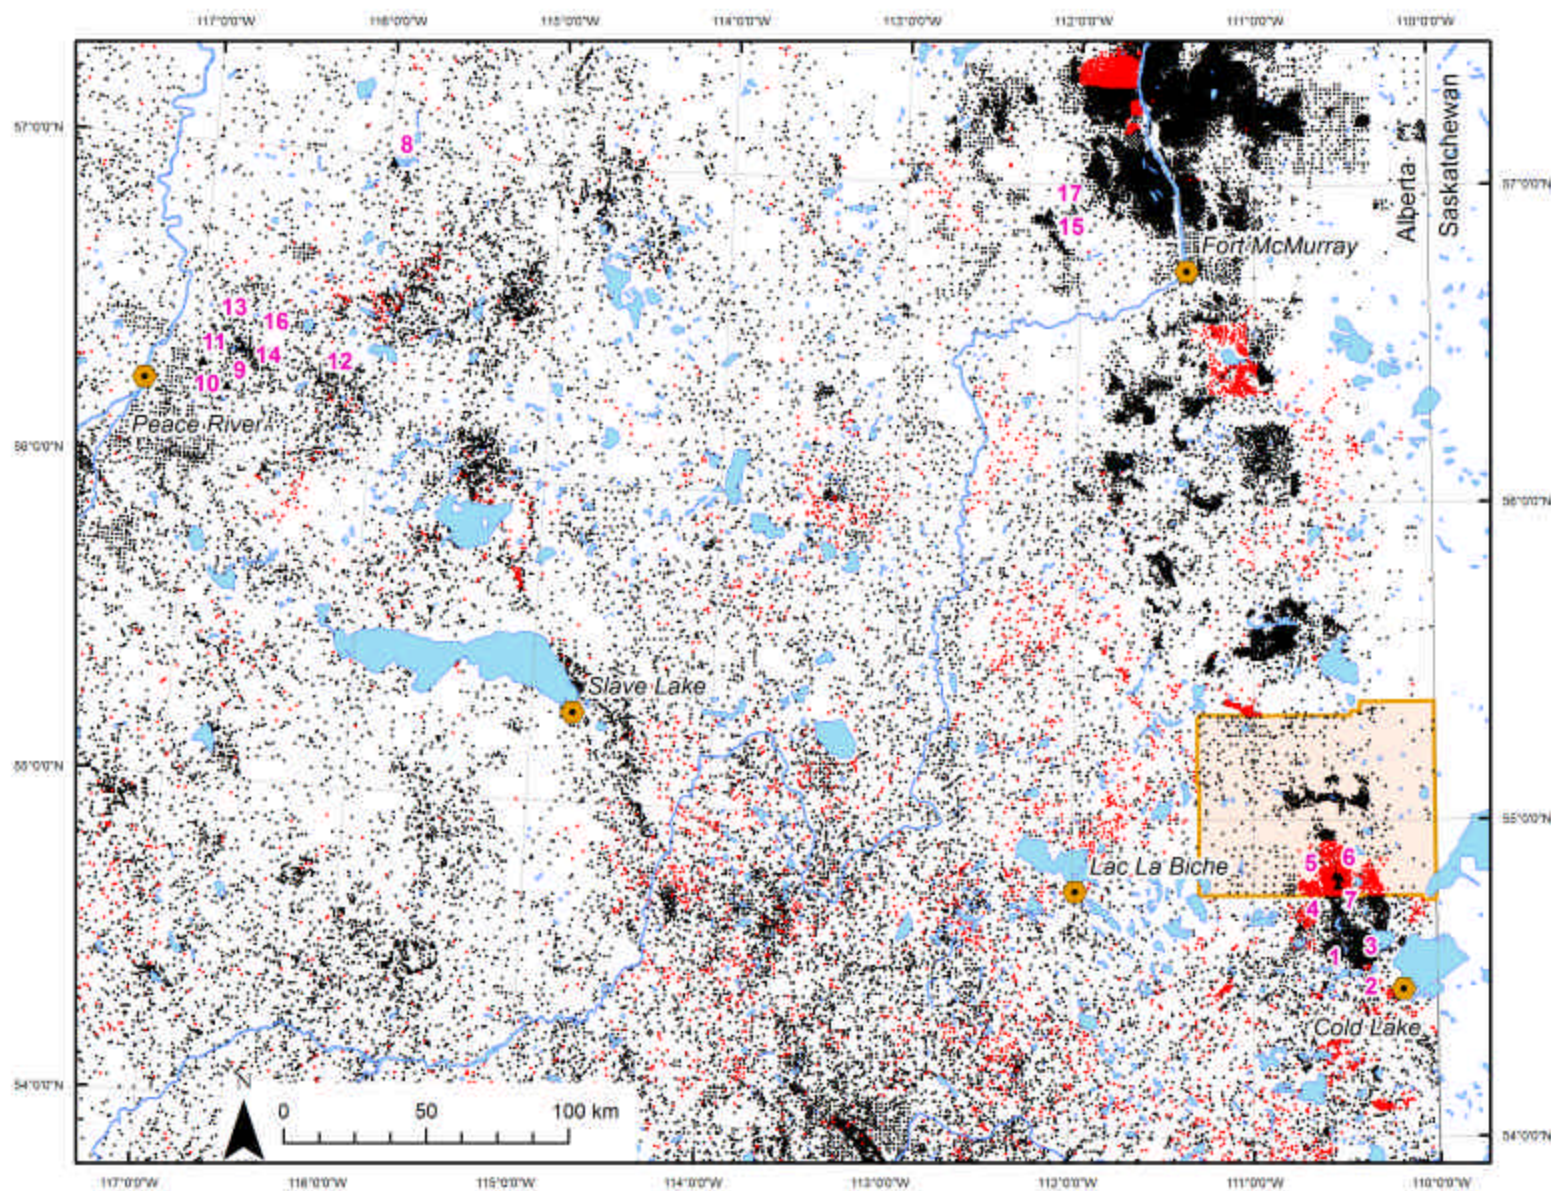
Given that there were 48,344 abandoned petroleum and natural gas wells in northern Alberta as of 25 August 2009 and 17 active and future cyclic steam stimulation projects in the same region (Figure 11, Tables 3 and 4), recent uncontrolled bitumen releases suggest that an in-depth, independent scientific investigation of the geological, hydrological, and ecological risks associated with HPCSS operations should be conducted immediately. High pressure cyclic steam stimulation methods may be leading to degradative changes in the quality of groundwater and the integrity and containment capability of bitumen reservoirs and may be placing adjacent ecosystems at risk of bitumen releases that are difficult to control. Expansion of *in situ* methods of bitumen exploitation across Alberta is outpacing the increase in knowledge of the potential below-ground and surface impacts of these methods. By the time the effects of these methods are sufficiently understood, it may be too late to remediate. Continued use of HPCSS may result in large and unpredictable costs, and those costs will not be borne by the energy companies but by future generations of Canadians.

Figure 11. The distribution of abandoned wells in northern Alberta in relation to cyclic steam stimulation projects. There were 19,027 abandoned wells in the region as of 25 August 2009. Red dots symbolize CNRL abandoned wells; black dots symbolize other company abandoned wells. Numbers refer to the projects listed in Table 3.
