**Canadian Natural**

## **PRIMROSE FLOW TO SURFACE CAUSATION REPORT**

**ALBERTA ENERGY REGULATOR AND ALBERTA ENVIRONMENT AND SUSTAINABLE RESOURCE  
DEVELOPMENT**

June 27, 2014

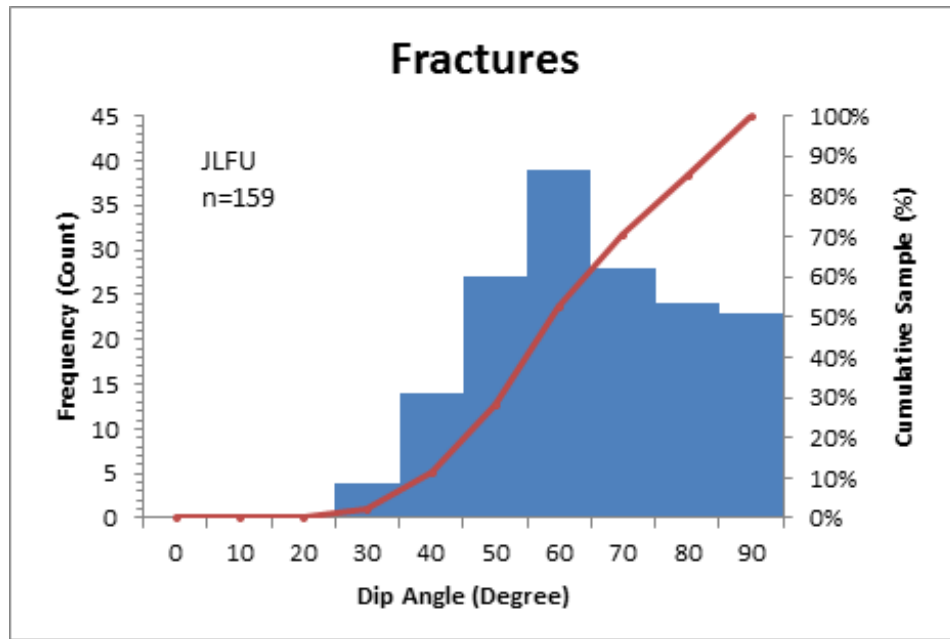
**Figure 4-1 Number and Dip Angle of Fractures Observed in the Joli Fou Formation**

The Joli Fou Formation is a thick mudstone which exhibits evidence of dewatering-induced soft sediment deformation. Natural fractures with high dip angles in the range of 30 to 90 degrees are observed on micro image logs (Figure 4-1). On Figure 4-1, Figure 4-2, Figure 4-3, Figure 4-4 and Figure 4-5, n represents the fracture count from micro image logs on the 50 Cretaceous wells drilled to date as part of this study.

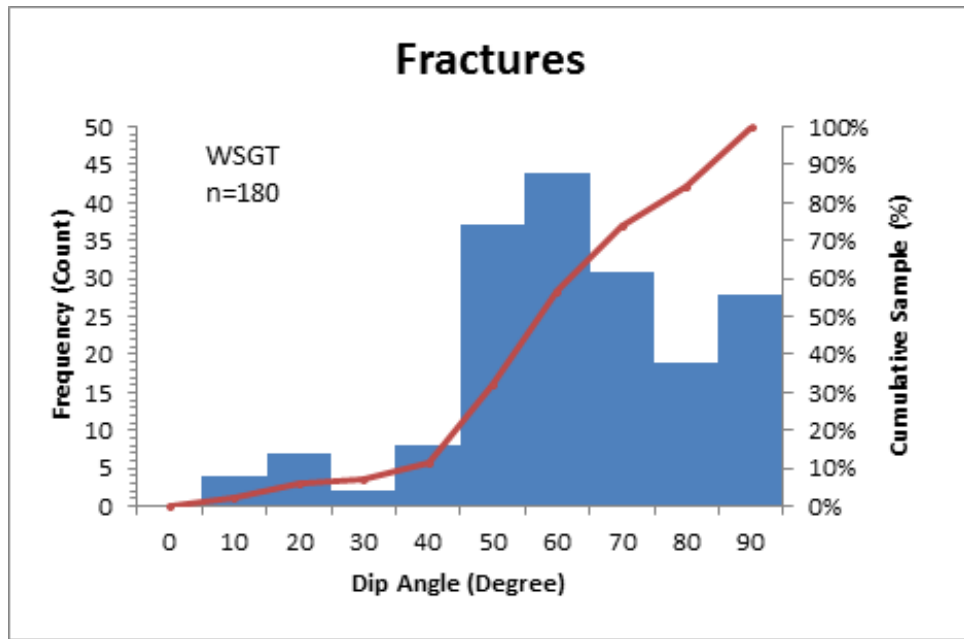
**Figure 4-2** Number and Dip Angle of Fractures Observed in the Westgate Formation

In the upper cycles of the Westgate Formation, the shales become more quartz-rich, sedimentary layering becomes more visible in core, and the number of fractures observed in core and on micro image logs tend to increase compared to the underlying Viking and Joli Fou formations. Over 90 percent of the natural fractures observed on micro image logs dip in the 40 to 90 degree range (Figure 4-2).

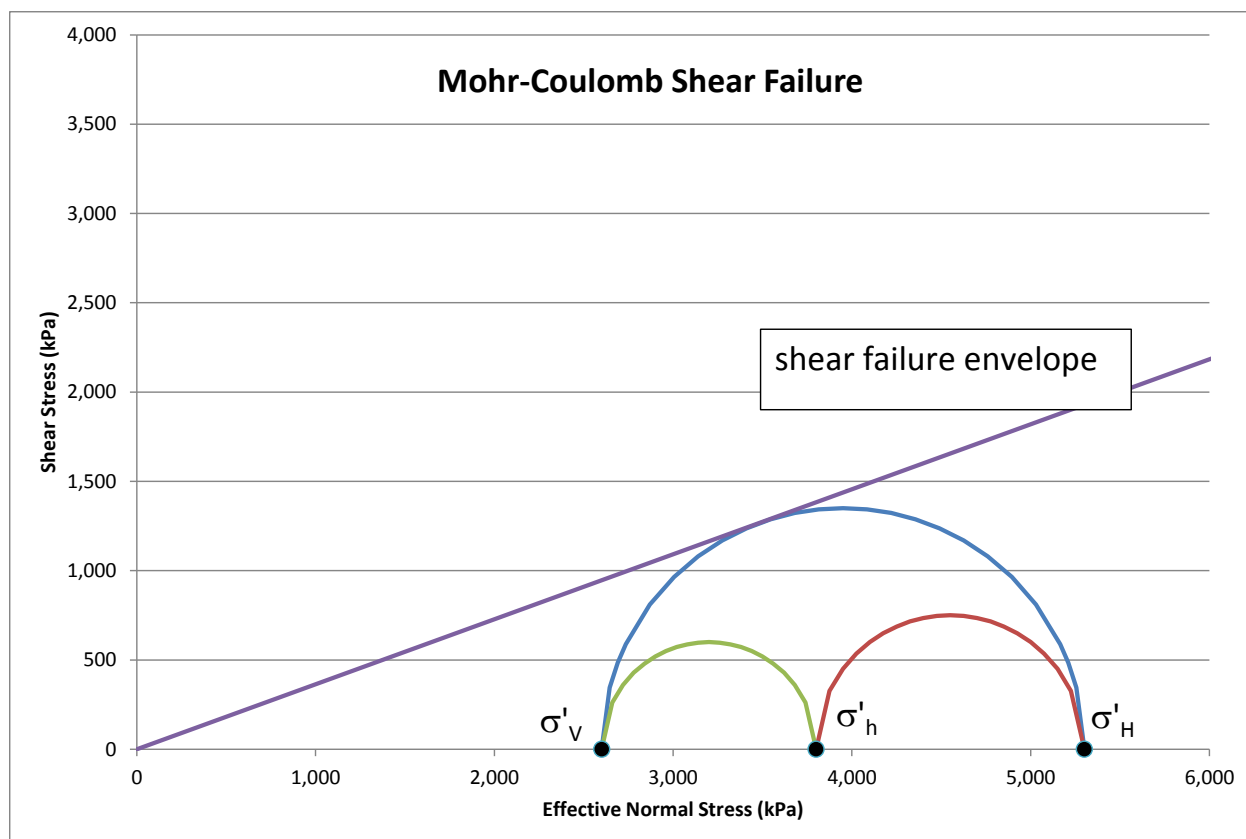
**Figure 6-3** A simplified example of shear failure of a natural fracture at a fluid pressure less than the hydraulic fracture pressure

An example of a natural fracture shear failure at a pressure below the hydraulic fracture pressure is illustrated in Figure 6-3. In this example, the following assumptions are used:

The near horizontal geometry of the bitumen emulsion in the above example indicates that shear failure of natural fractures and faults intersected did not appreciably change the direction of the bitumen emulsion movement. This is interpreted that the permeability enhancement was insufficient to divert material bitumen emulsion flow from the horizontal fracture. This also indicates that the shear strain associated with intersected faults does not appear to have resulted in significantly different hydraulic conductivity behavior between faults and natural fractures. These results indicate that the flow capacity of natural fractures and faults can be overwhelmed by the rate of injection creating a horizontal hydraulically induced fracture.

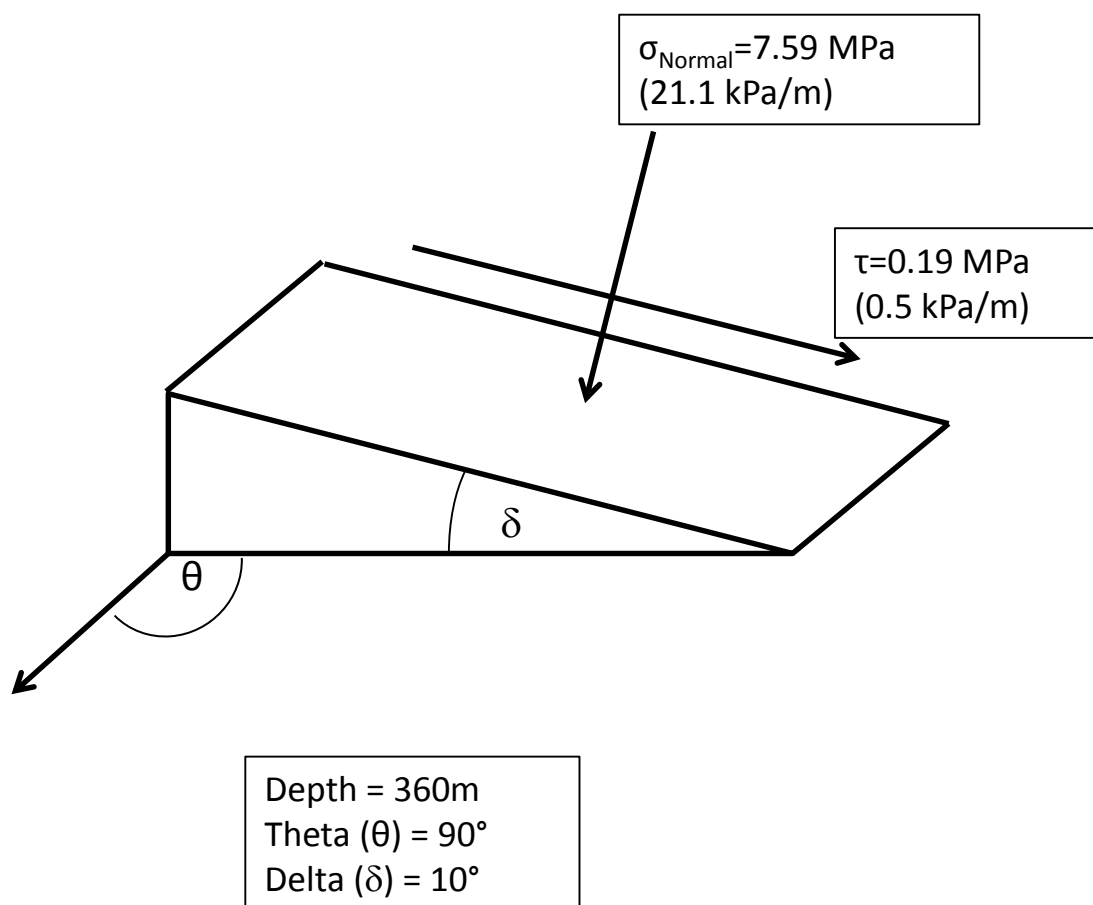
**Figure 6-4** Example of stresses acting on a natural fracture with a 10 degree dip at a depth of 360 m

This hydraulically induced tensile failure of a natural fracture or fault can be illustrated in Figure 6-4 with an example of an element of rock from the Joli Fou Formation at a depth of 360 m using typical in-situ stresses from the data acquisition. In this example, a natural fracture is illustrated with a dip angle of 10 degrees and a strike parallel to the orientation of the maximum horizontal principal stress.

Brazilian tests of Joli Fou Formation samples have found tensile strengths of 160 – 200 kPa (TerraTek 2014, BitCan 2013). In the above example, the difference between the normal stress and the vertical stress is less than the tensile strength. As such, an induced horizontal hydraulic fracture may turn into this natural fracture due to tensile strength of the matrix providing greater resistance than the

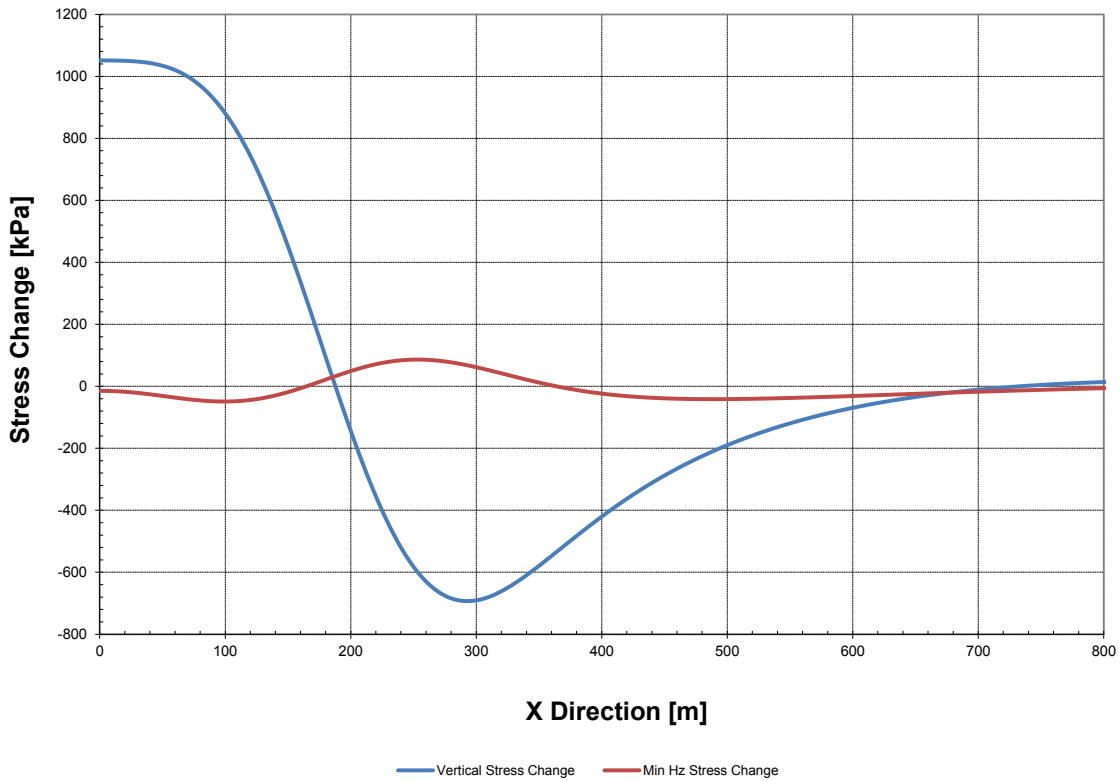
**Figure 6-5** Example of total stress changes with distance away from the center of the Clearwater uplift profile at a depth of 360 m

At the depth of the base of the Joli-Fou (~360 m) and with the stresses assumed to be as in Figure 6-2, induced stress changes above a region of uplift were capable of making the vertical and minimum horizontal stresses converge if the Clearwater capping shale uplift was 0.6 m. Figure 6-5 illustrates the change in stress at the base of the Joli Fou Formation (360 m depth) under these conditions. One caveat is that more work needs to be done to confirm the relationship between uplift and the absolute magnitude increase in stress. The assumptions used are:

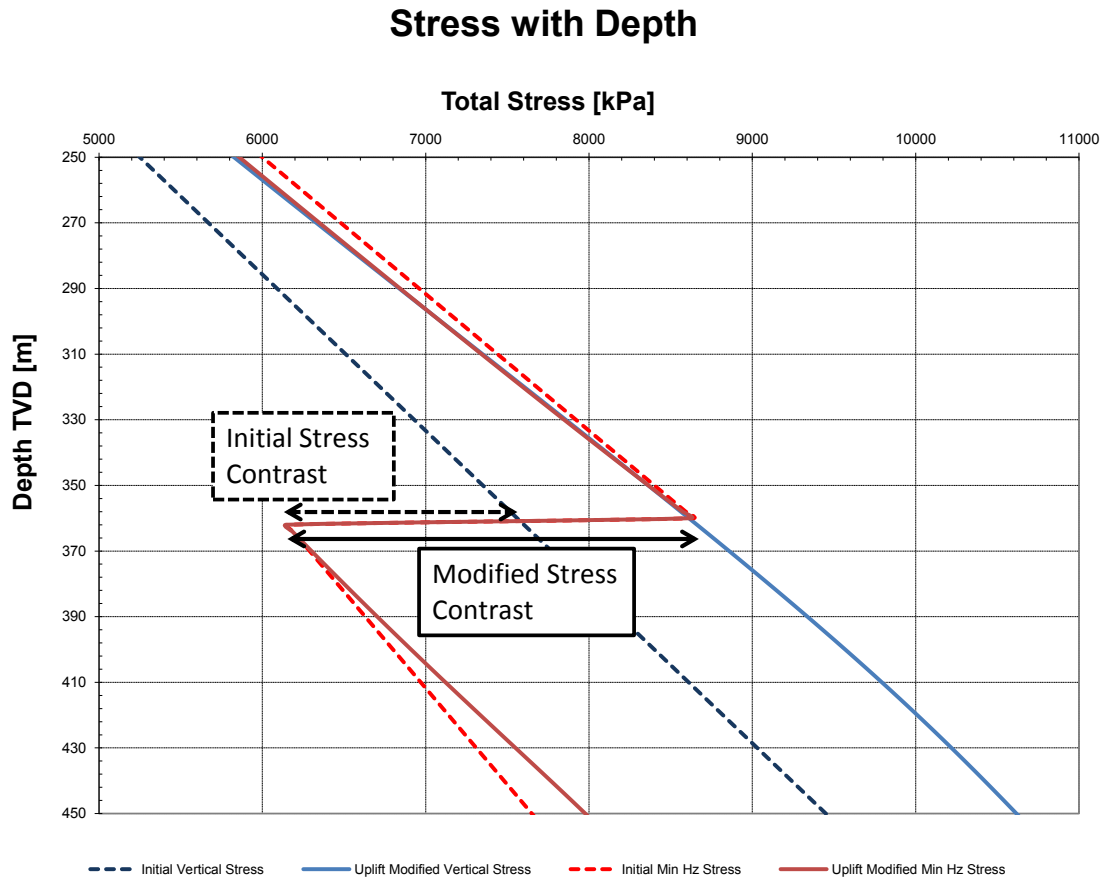
**Figure 6-6** Example of calculated total stress changes with depth and effects of vertical stress approaching the minimum horizontal stress

Applying the results in Figure 6-5 on the stresses in Figure 6-2, the results are illustrated in Figure 6-6 where at a depth of 360 m, the initial vertical principal stress was 7.6 MPa and increased to 8.7 MPa ( $\sim 24$  kPa/m). The initial minimum horizontal principal stress was 8.7 MPa ( $\sim 24$  kPa/m) and decreased by 30 kPa. It is important to note that this convergence is dominated by the vertical stress increase and the horizontal stress change tends to be one order of magnitude lower within the Joli Fou Formation. Directly over the Clearwater reservoir uplift, the increased vertical stress at the base of the Joli Fou Formation results in a substantially increased minimum stress contrast between the Grand Rapids and Joli Fou Formations. In order to initiate hydraulically induced fracturing within the Joli Fou Formation in this example, the pressure requirement has increased by 1.1 MPa as shown in Figure 6-5.

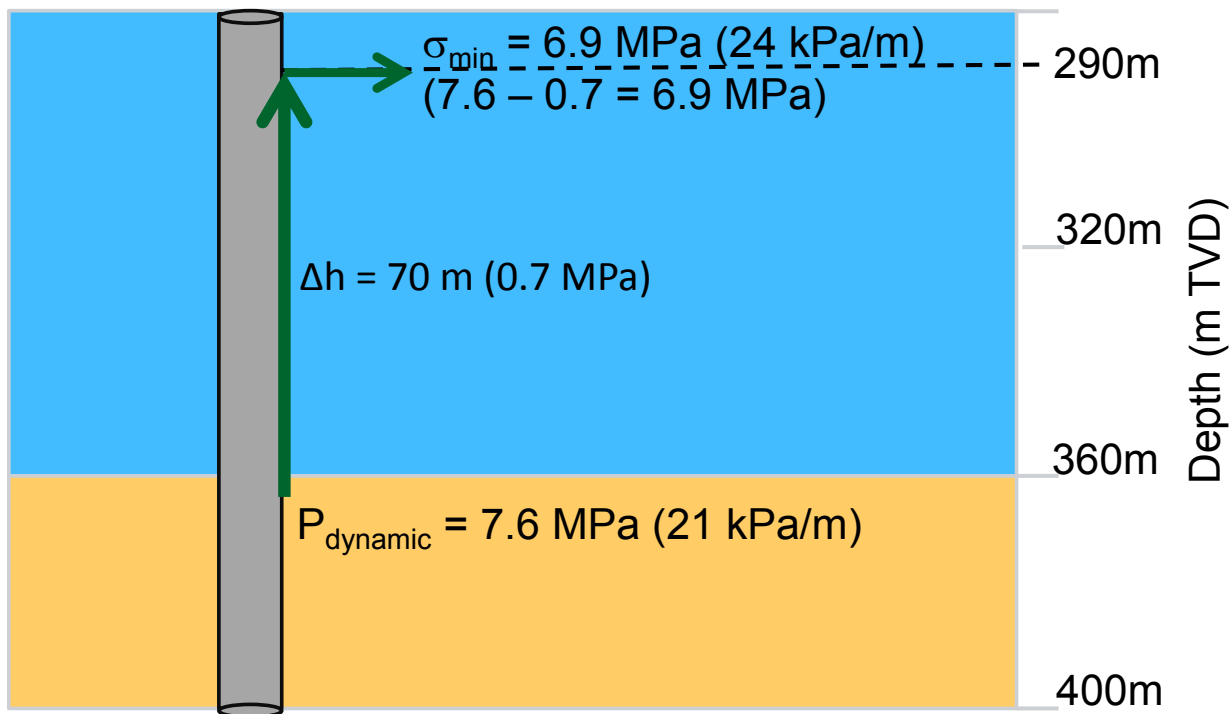
**Figure 6-7** Example of pressures required for initiation of hydraulically induced fracturing in the Lower Colorado

The uplift induced stress changes increase the likelihood of a wellbore being involved due to the increased fracture pressure within the Joli Fou Formation above the Clearwater reservoir uplift. One example is shown in Figure 6-7 of a wellbore with inadequate hydraulic isolation illustrating a relatively low pressure to initiate and propagate hydraulic fracturing within the Colorado Group. A fluid gradient of 10 kPa/m and no frictional effects was assumed for the example below.

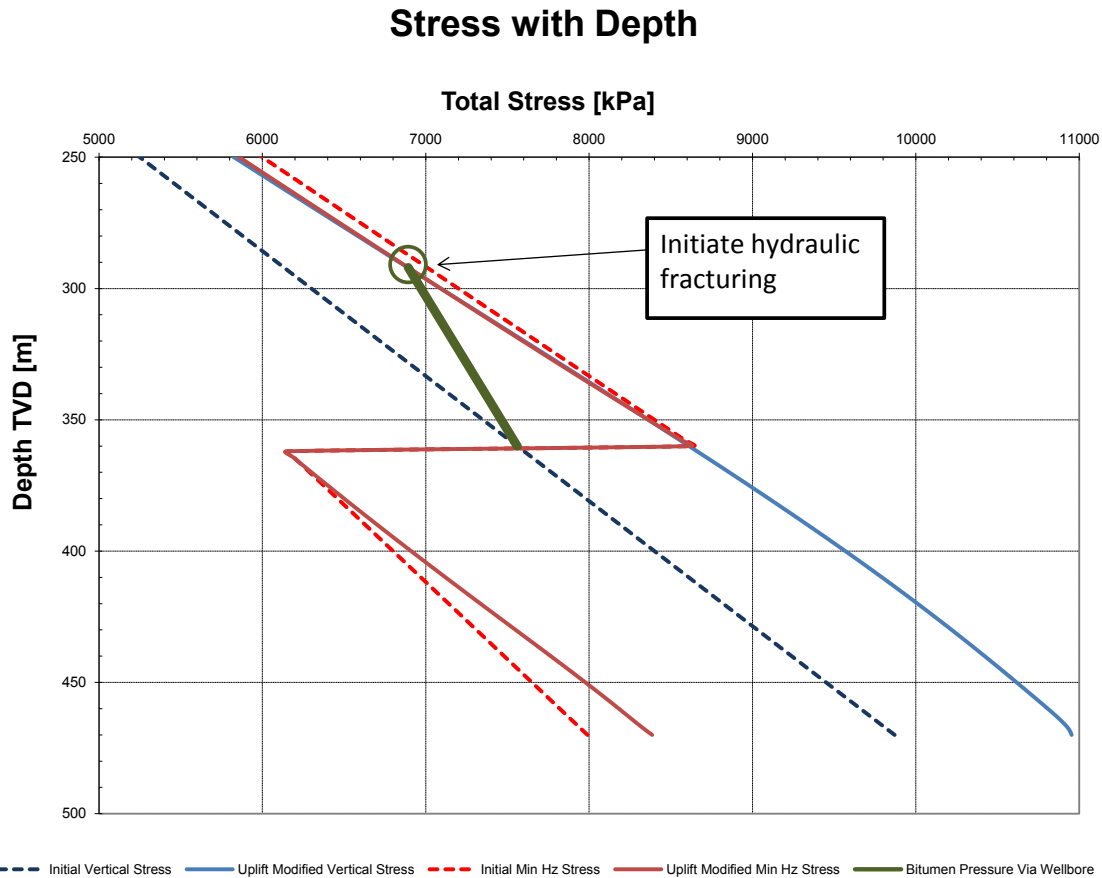
**Figure 6-8**      **Example of stress change with depth and pressure profile along a wellbore path intersecting the minimum stress**

Building upon Figure 6-6 an example pressure profile of bitumen emulsion flowing up a wellbore pathway is illustrated in Figure 6-8.

- 2 Build sufficient dynamic fracture pressure at the top of the Grand Rapids Formation to a magnitude above the minimum horizontal principal stress at the base of the Joli Fou Formation.

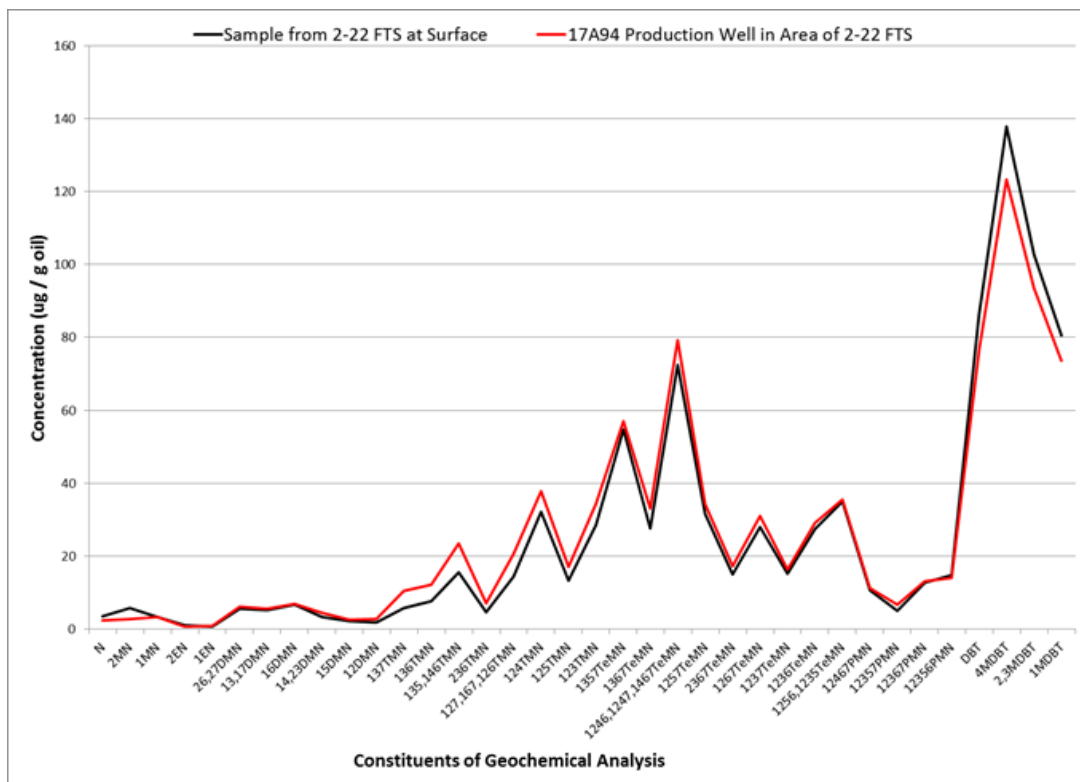
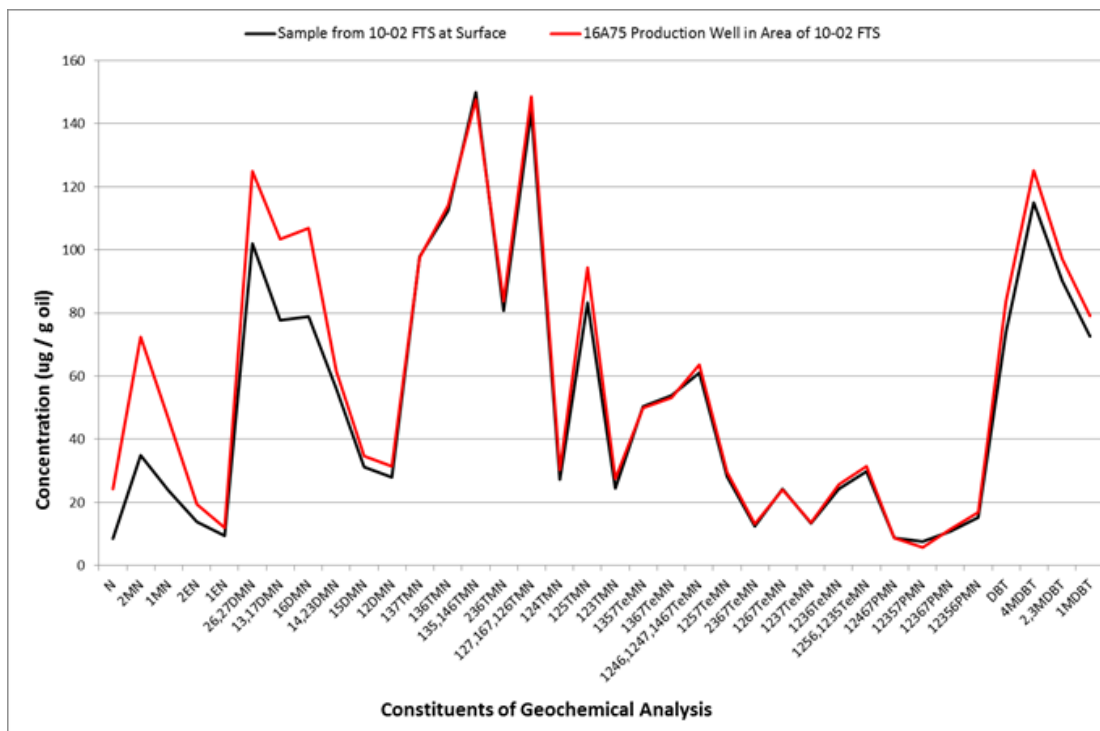
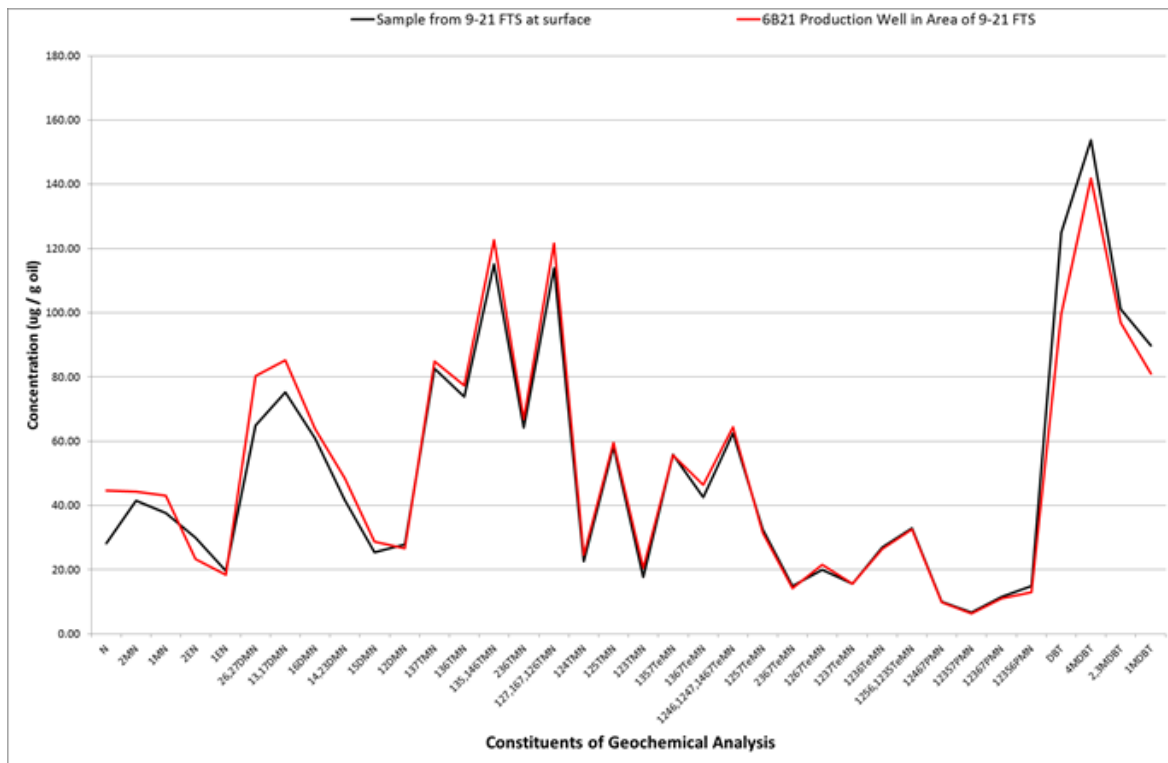
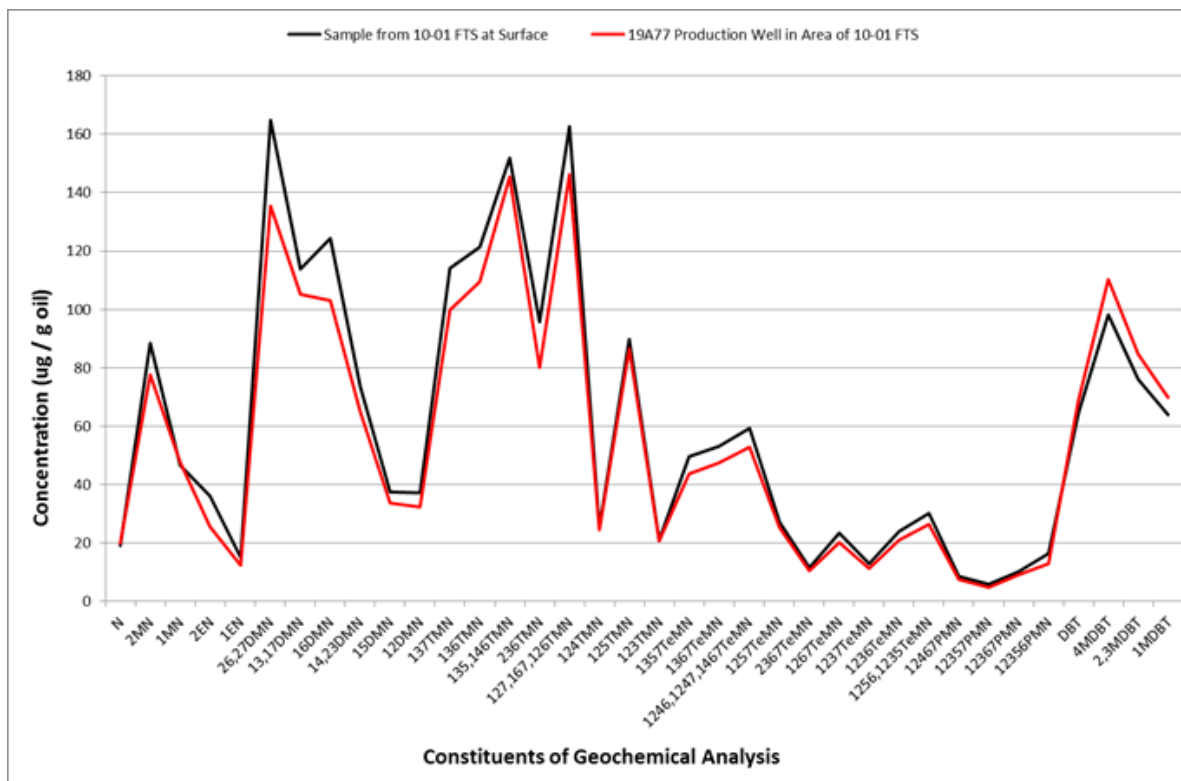
Fluid leaving the Clearwater reservoir initiates FTS events. Geochemical analysis has shown a relationship between the fluid recovered at surface and the fluid in the Clearwater reservoir. This is shown in Figure 8-1, Figure 8-2, Figure 8-3 and Figure 8-4. Acronyms for Figure 8-1, Figure 8-2, Figure 8-3 and Figure 8-4 can be found in Table 8-1.

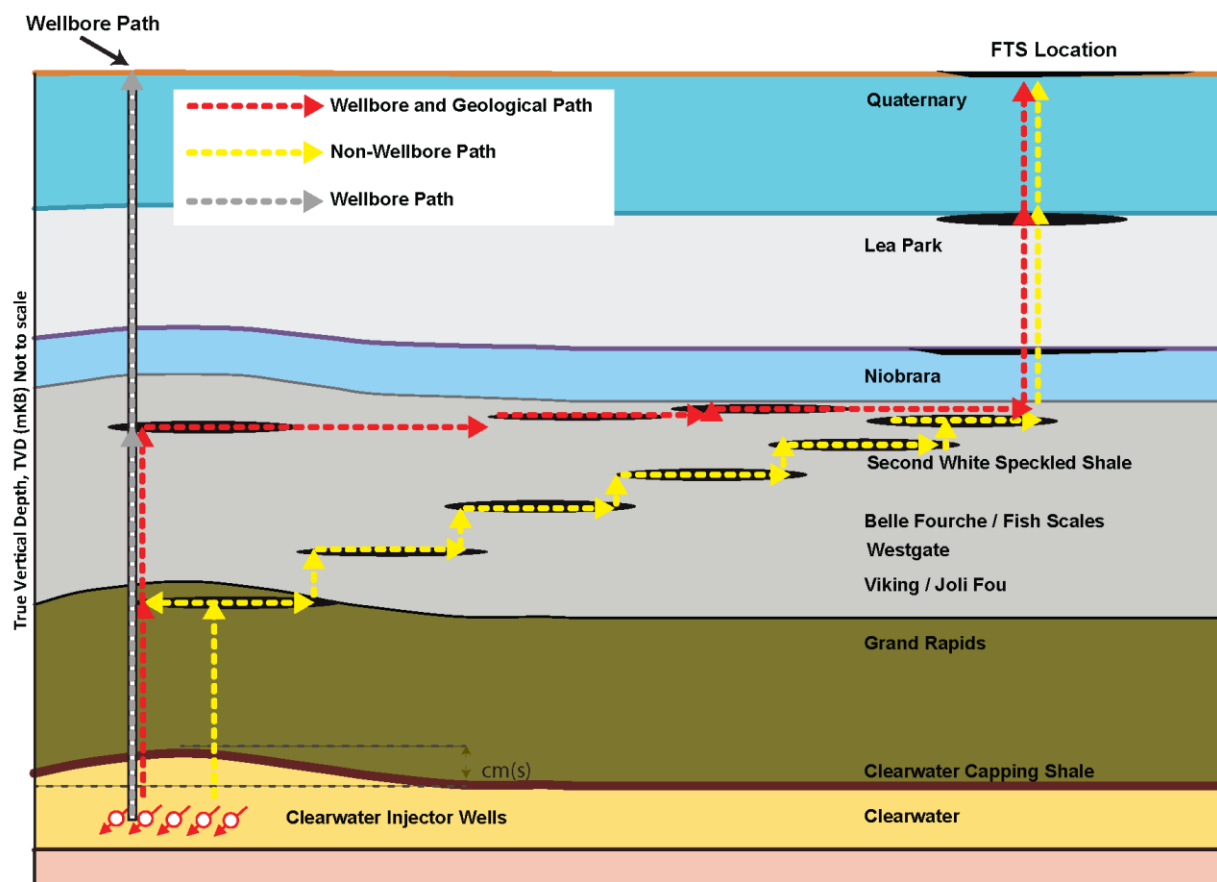
**Figure 9-1 Conceptual Flow Path for FTS**

As shown in Figure 9-1, the three potential paths to surface are:

Possible geomechanical enhanced conduits are induced features such as:

- Hydraulically induced fractures
- Hydraulically induced opening of natural fractures
- Hydraulically induced opening of faults
- Hydraulically induced opening of bedding plane

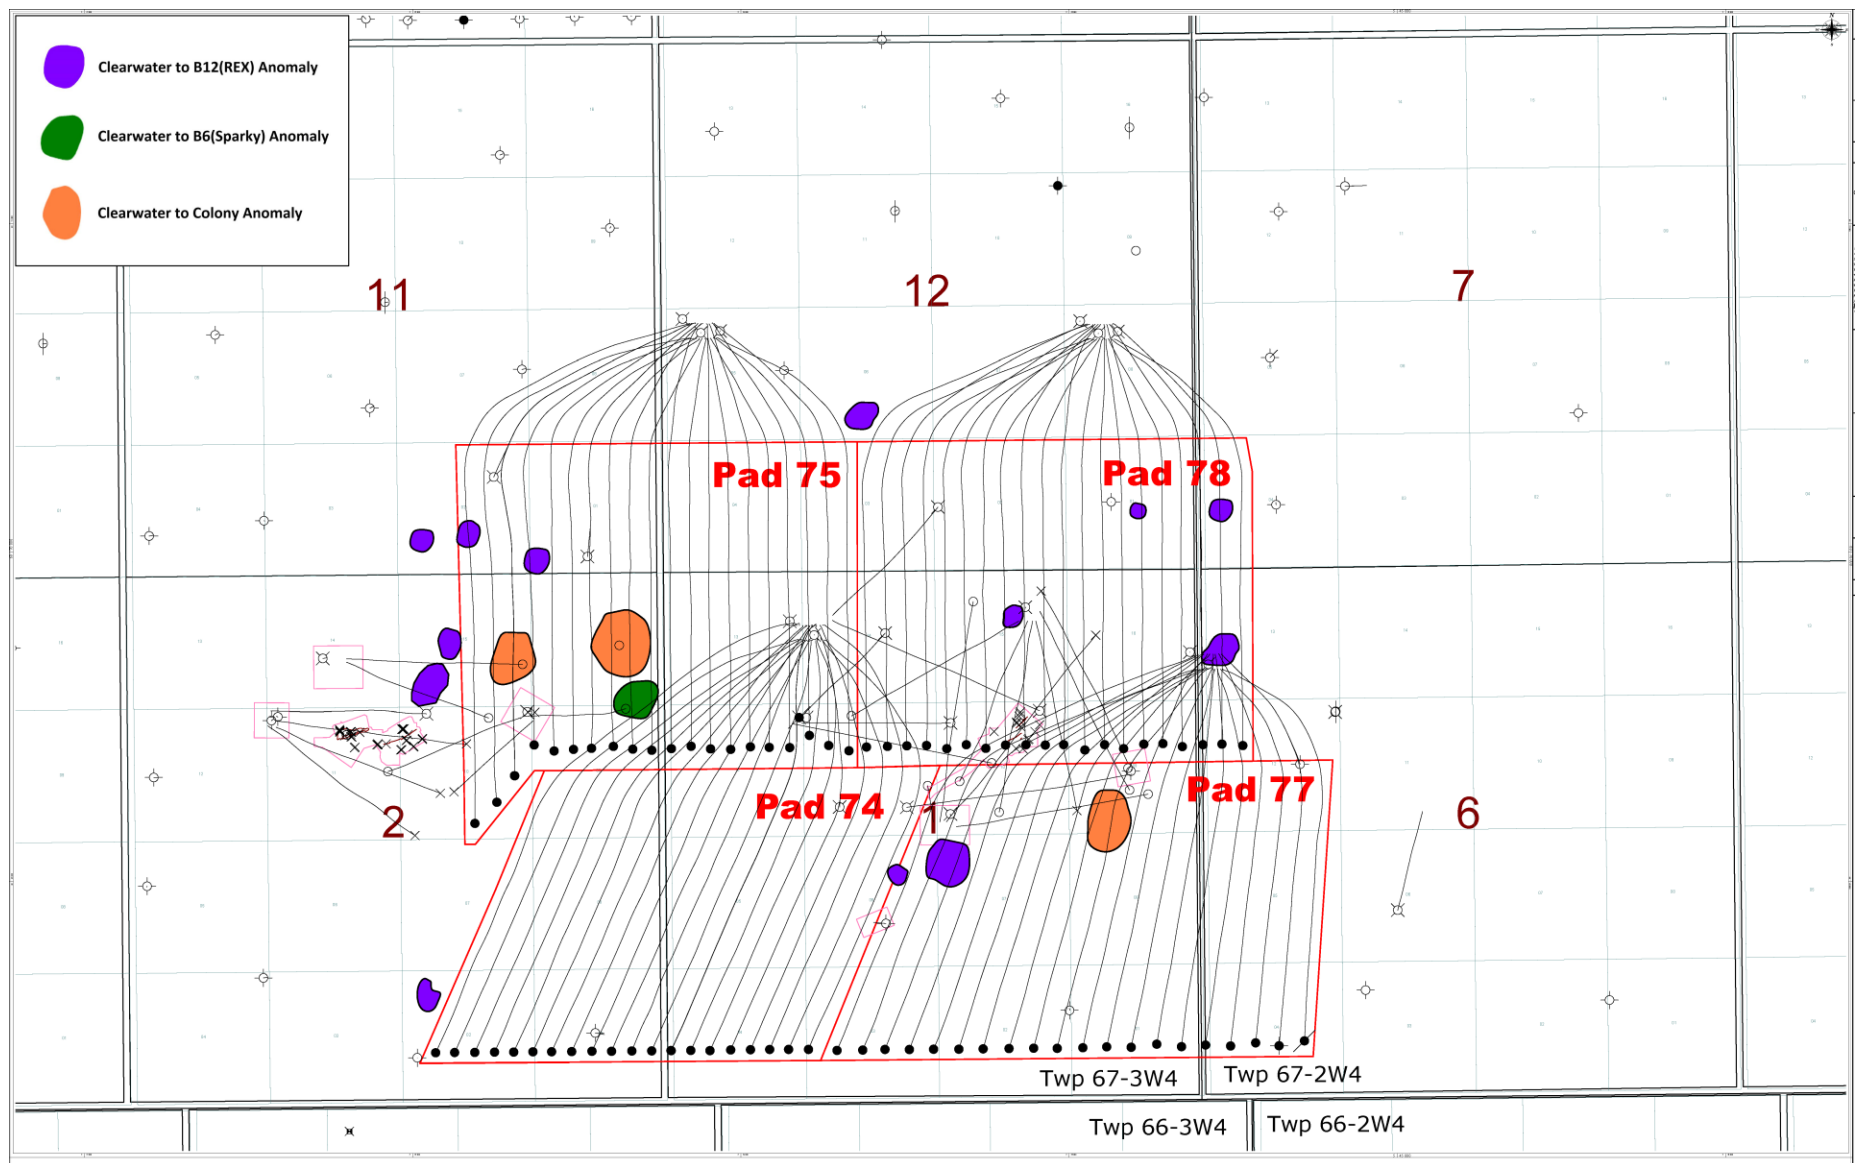
**Figure 9-2** Simplified Grand Rapids Formation Post Steam Seismic Anomaly Location Map for PRE Area 1

Analysis of post-steam seismic anomalies within the Grand Rapids Formation, illustrates that flows of sufficient volume and duration, to reach the top of the Grand Rapids Formation are relatively uncommon. The Grand Rapids Formation post-steam seismic anomalies are shown in Figure 9-2 and Figure 9-3.

These seismic anomalies are characterized by highly localized often circular amplitude changes and push down effects observed in post steam seismic volumes. Modelling and drilling data suggests the seismic features are observed because of the presence of liberated solution gas from the bitumen, but pressure and temperature effects may also play a role. Mapping of these anomalies shows that most do not extend to the top of the Grand Rapids Formation.

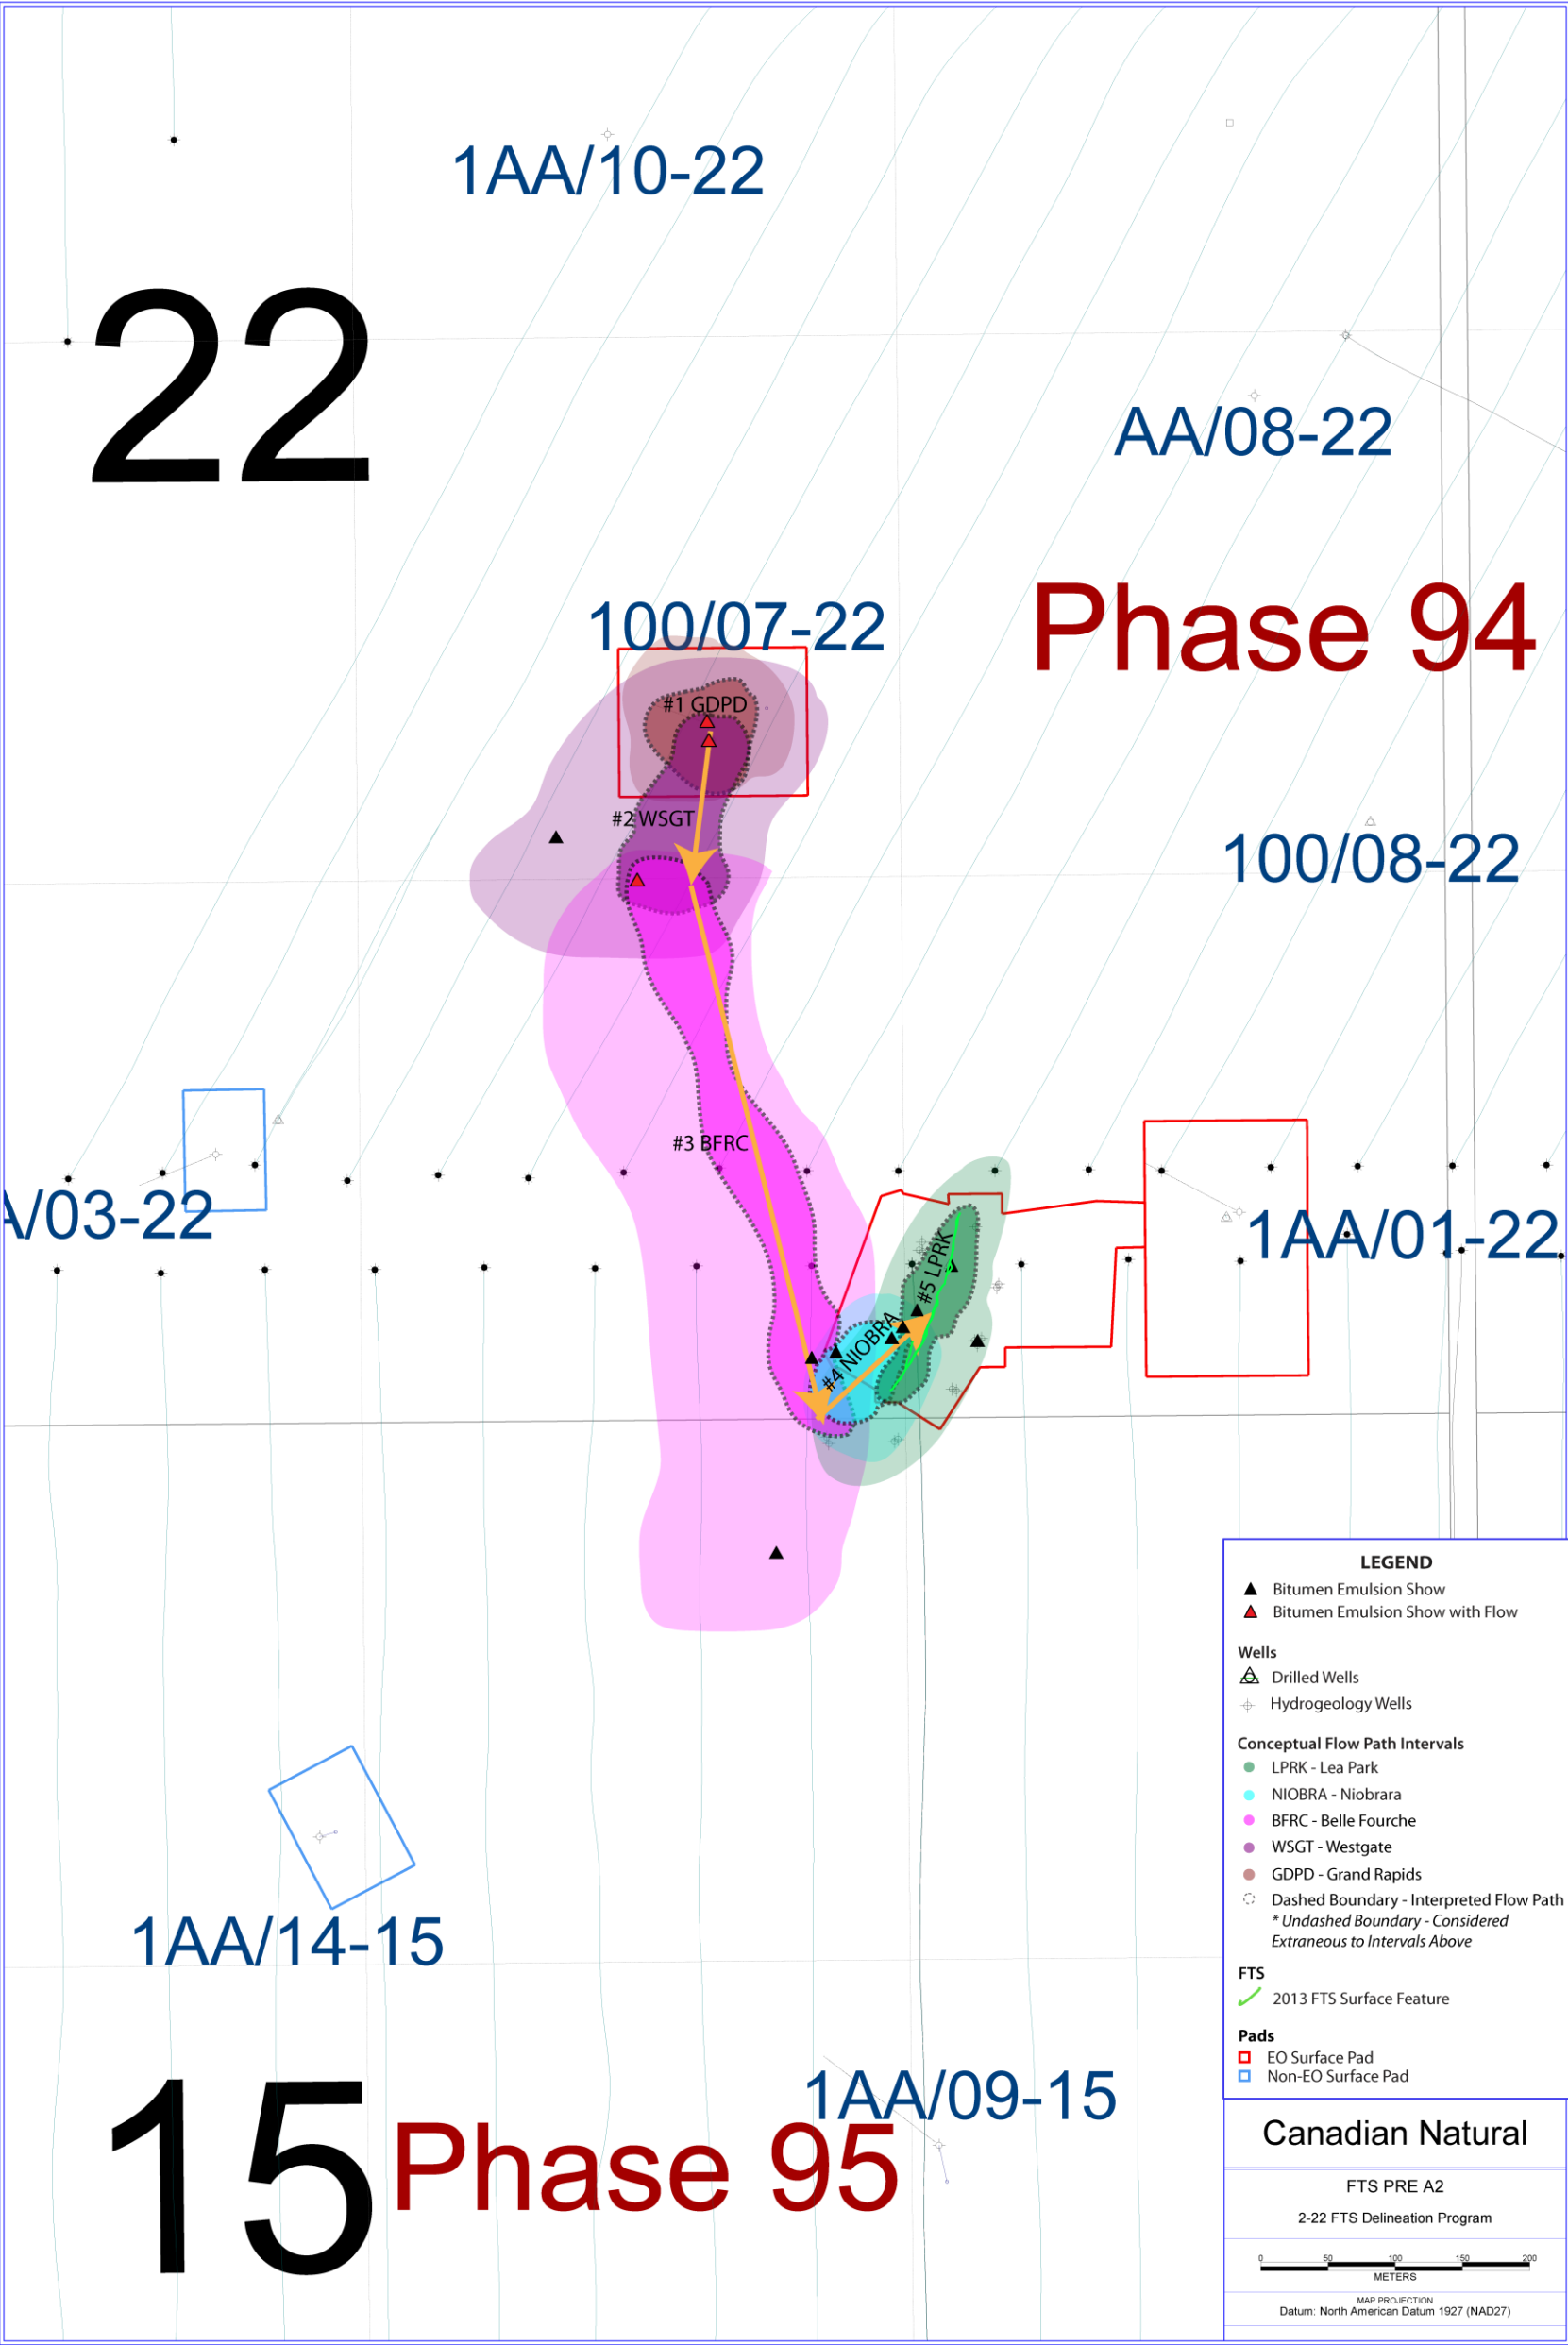
Figure 10-2 2-22 FTS – Conceptual Plan View of Bitumen Emulsion Shows

The study into the cause of bitumen emulsion being released from the Clearwater reservoir and flowing to surface at 2-22 in PRE A2 has generated the following pathway description (Figure 10-1 and Figure 10-2):

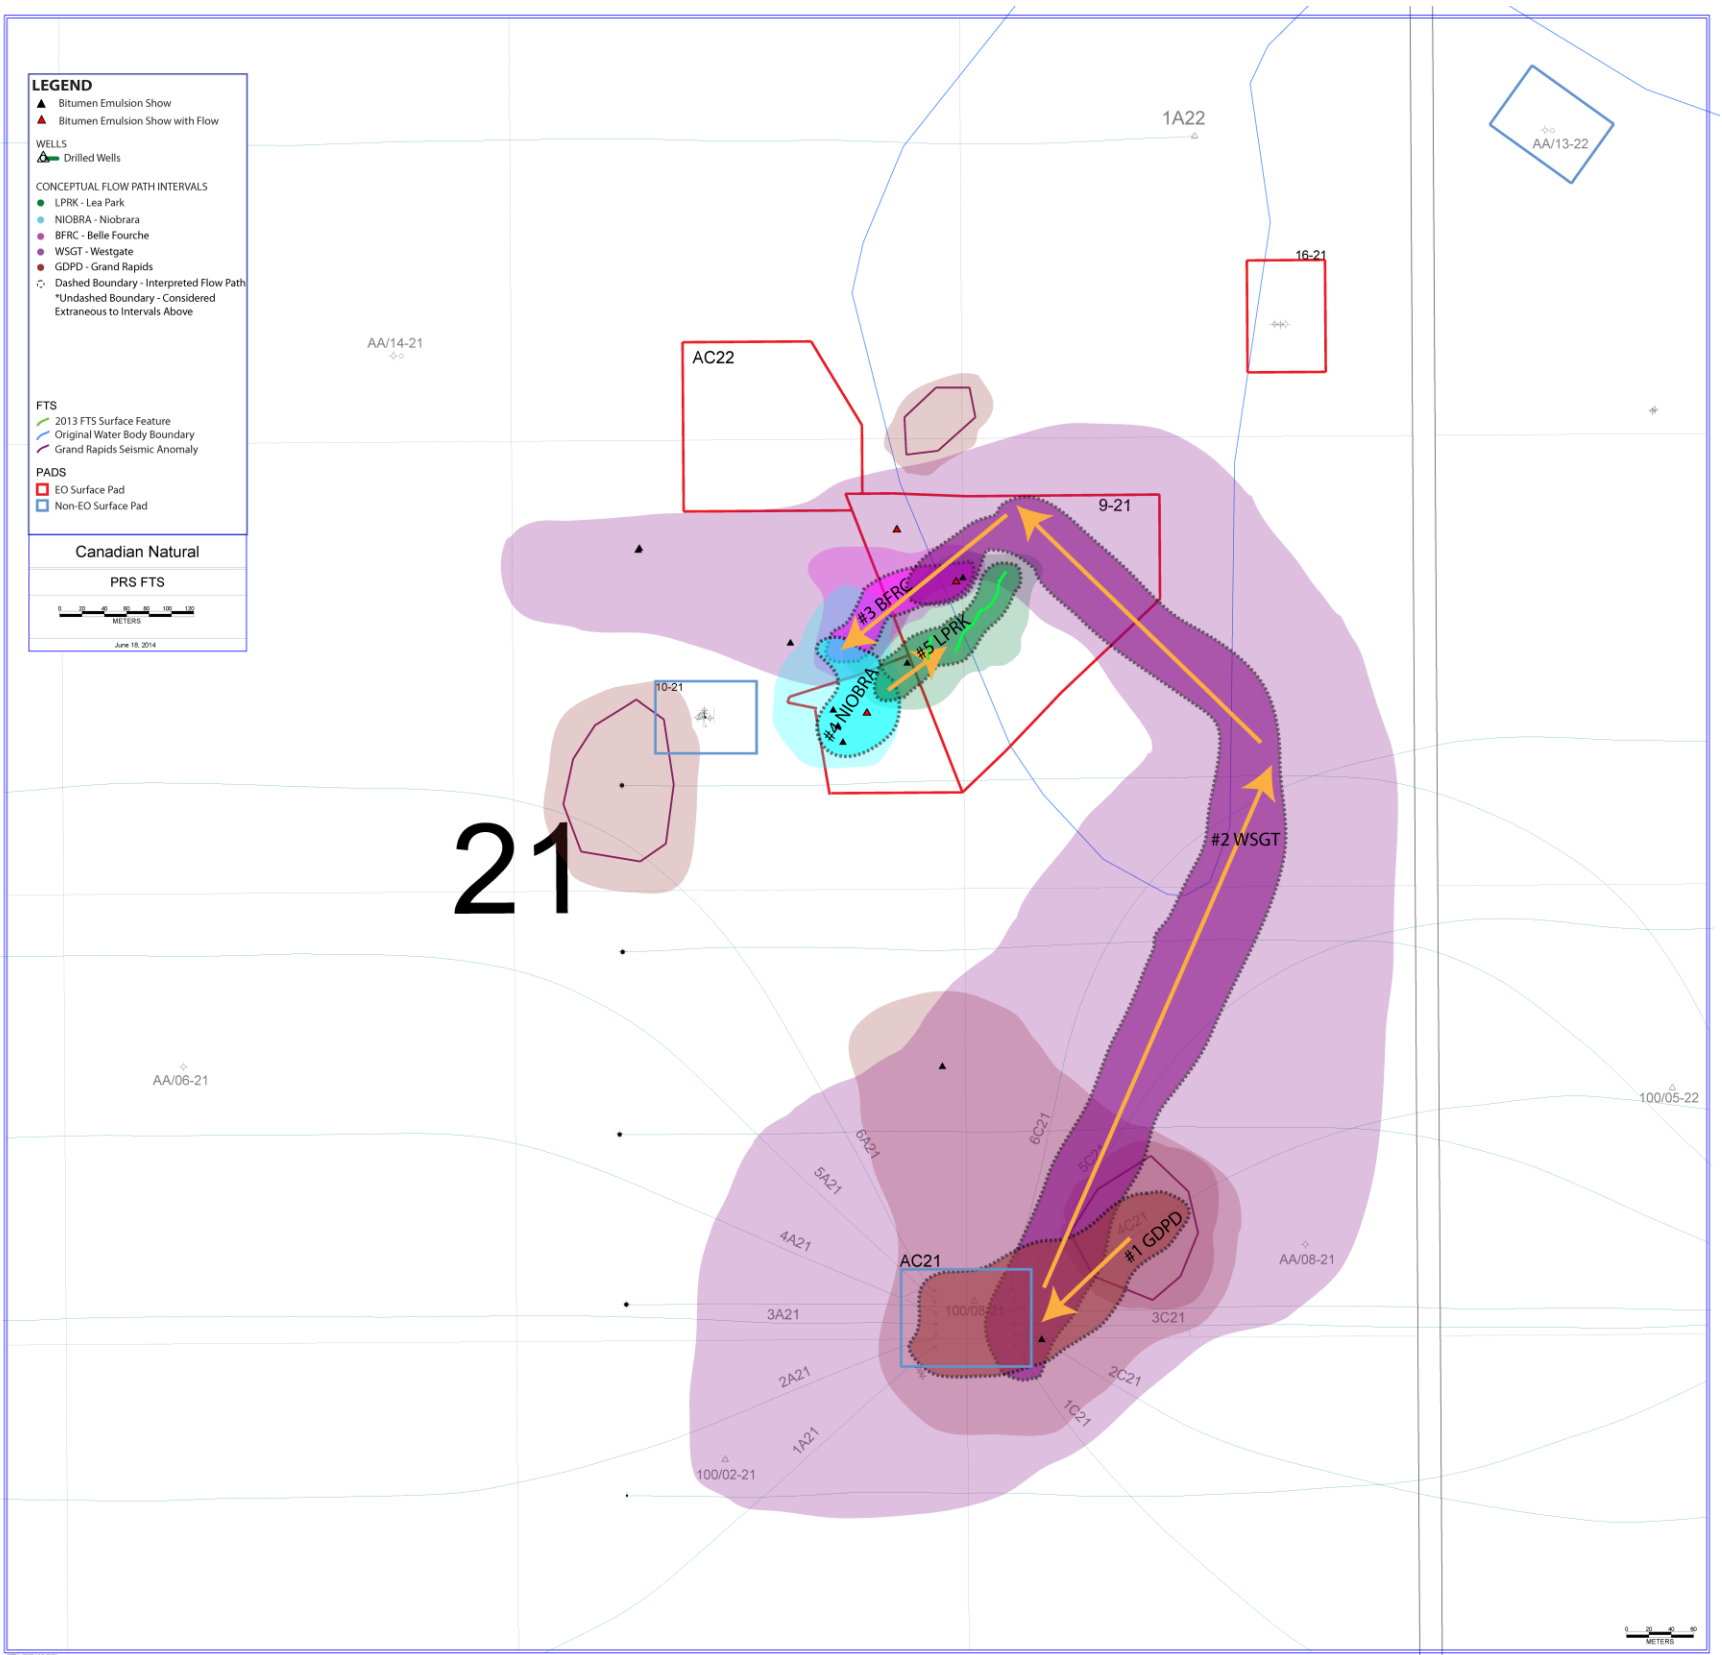
**Figure 10-6 9-21 FTS – Conceptual Plan View of Bitumen Emulsion Shows**

The study into the cause of bitumen emulsion being released from the Clearwater reservoir and flowing to surface at 9-21 in PRS has generated the following pathway description (Figure 10-5 and Figure 10-6). The study of this site is ongoing with alternative pathways being considered:
