**Canadian Natural**

## **PRIMROSE FLOW TO SURFACE CAUSATION REPORT**

**ALBERTA ENERGY REGULATOR AND ALBERTA ENVIRONMENT AND SUSTAINABLE RESOURCE  
DEVELOPMENT**

June 27, 2014

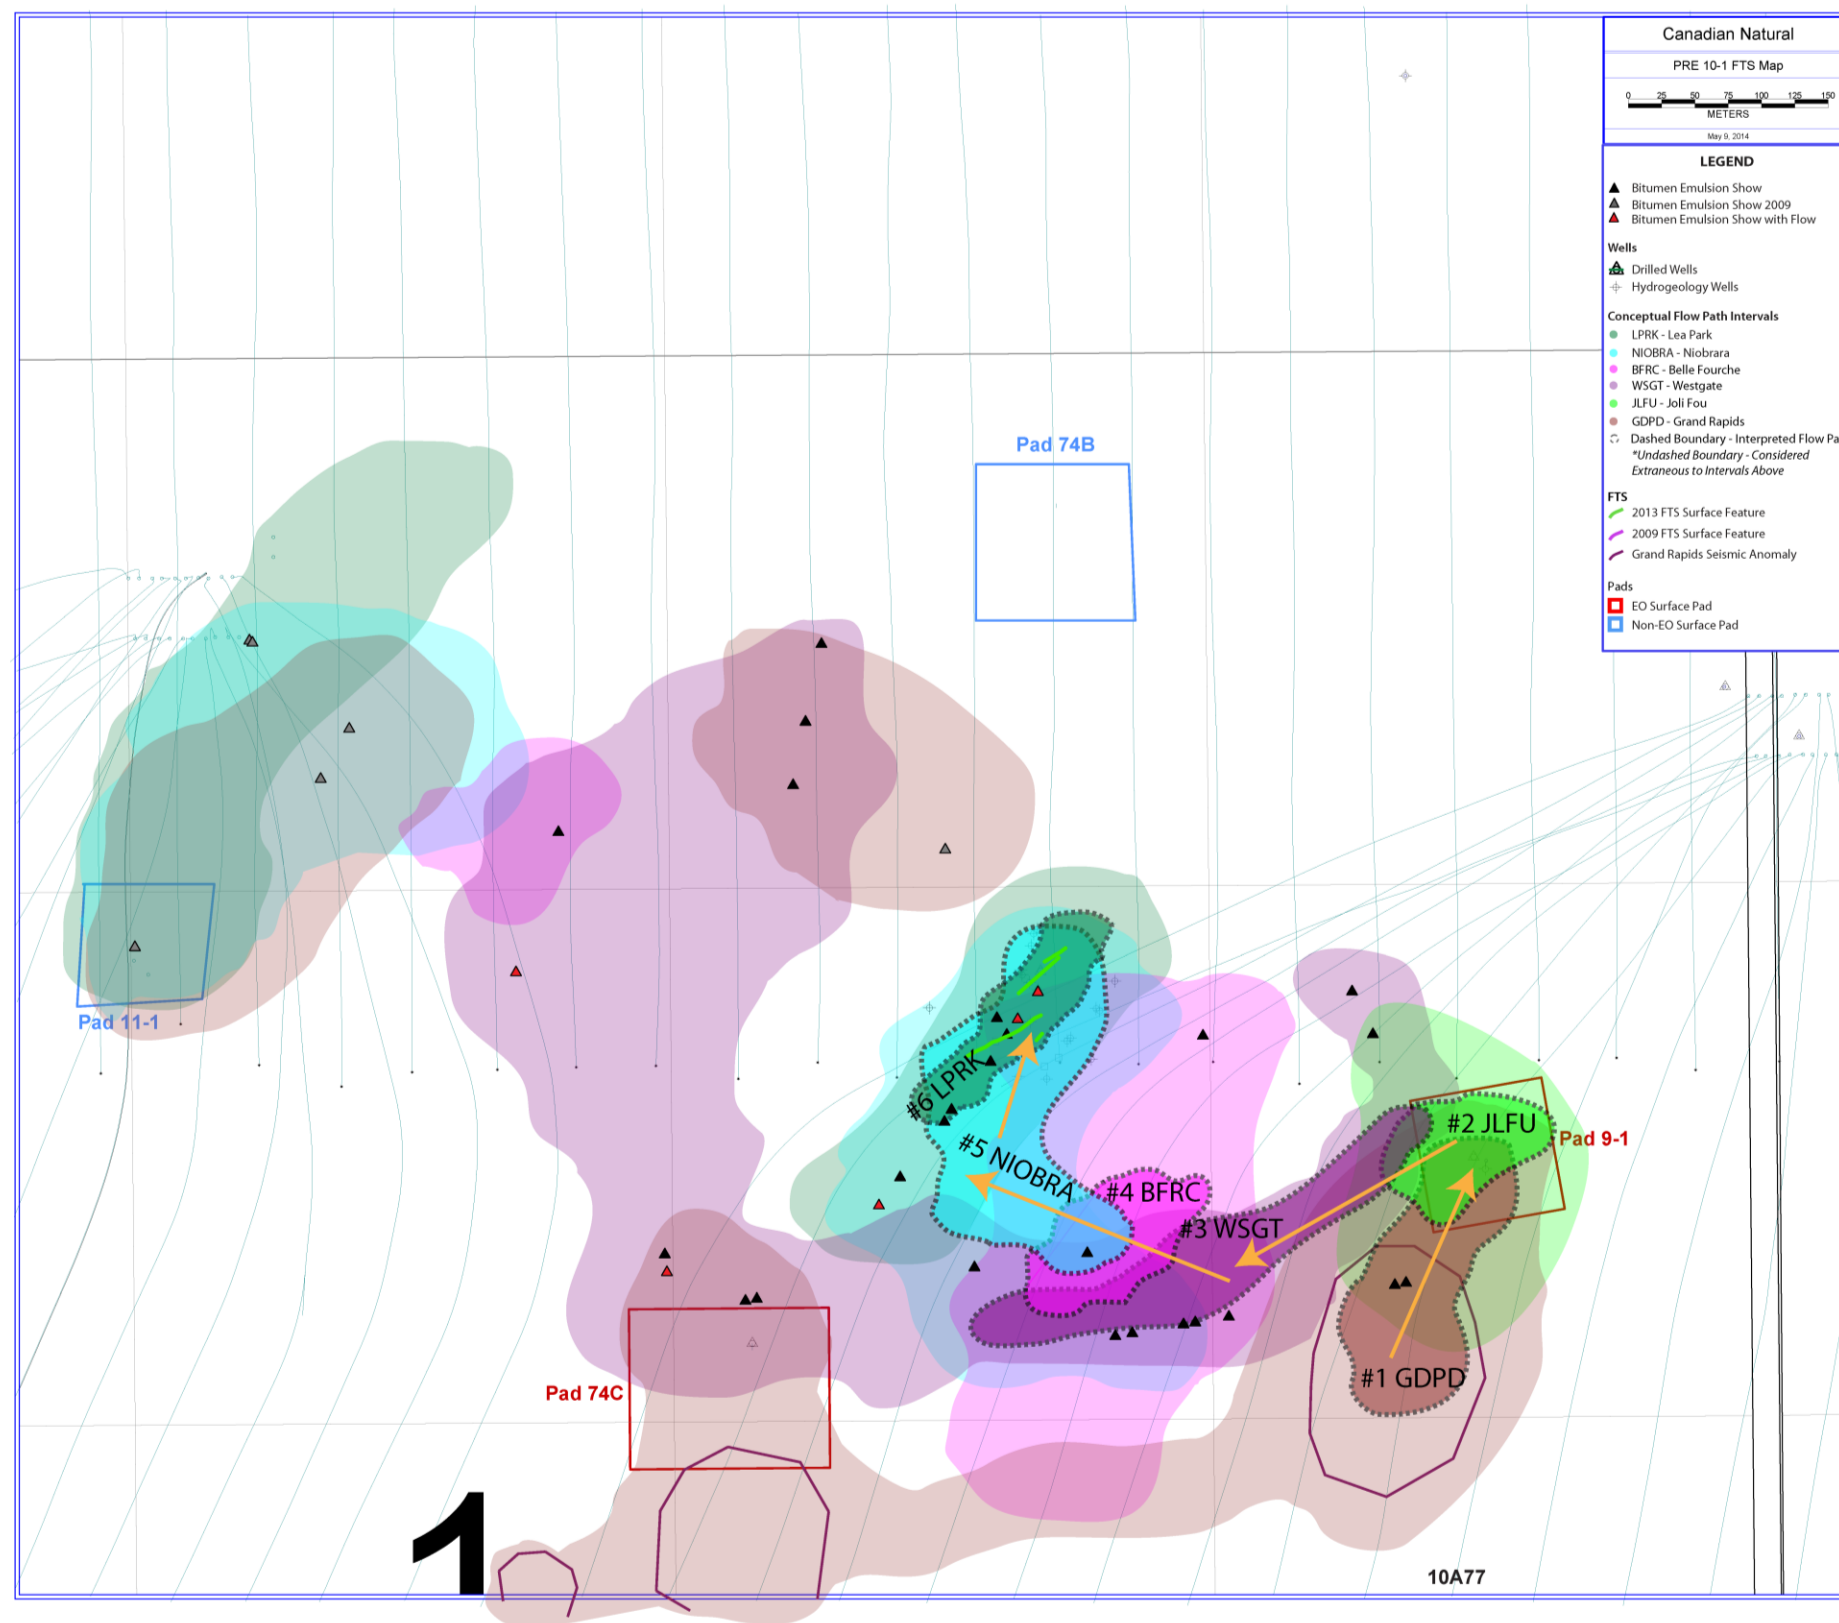
Figure 10-10 10-1 FTS – Conceptual Plan View of Bitumen Emulsion Shows

The study into the cause of bitumen emulsion being released from the Clearwater reservoir and flowing to surface at 10-1 in PRE A1 has generated the following pathway description (Figure 10-9 and Figure 10-10):

- Bitumen emulsion is not observed above the Joli Fou Formation in proximity to this wellbore. Above this point the flow path exits the wellbore.
- The flow path from the Viking Formation to the base of the Niobrara Formation involves a combination of horizontal hydraulically induced fractures connected by natural fractures, faults and bedding planes which have had permeability increases likely facilitated by uplift induced stress changes.

- The combination of natural fractures and faults with horizontal hydraulically induced fractures can cause a gradual climb from the Joli Fou Formation at the 1AA/09-01-067-03W4 OSE wellbore towards the FTS site at 10-1.
